Report No. 1792/2

**GEOENVIRONMENTAL APPRAISAL**  
**of land at**  
**MOORTHORPE GATE, OWLTHORPE**

**Prepared for**  
**KIER SERVICES**

## MOORTHORPE GATE, OWLTHORPE - SUMMARY OF GEOENVIRONMENTAL ISSUES

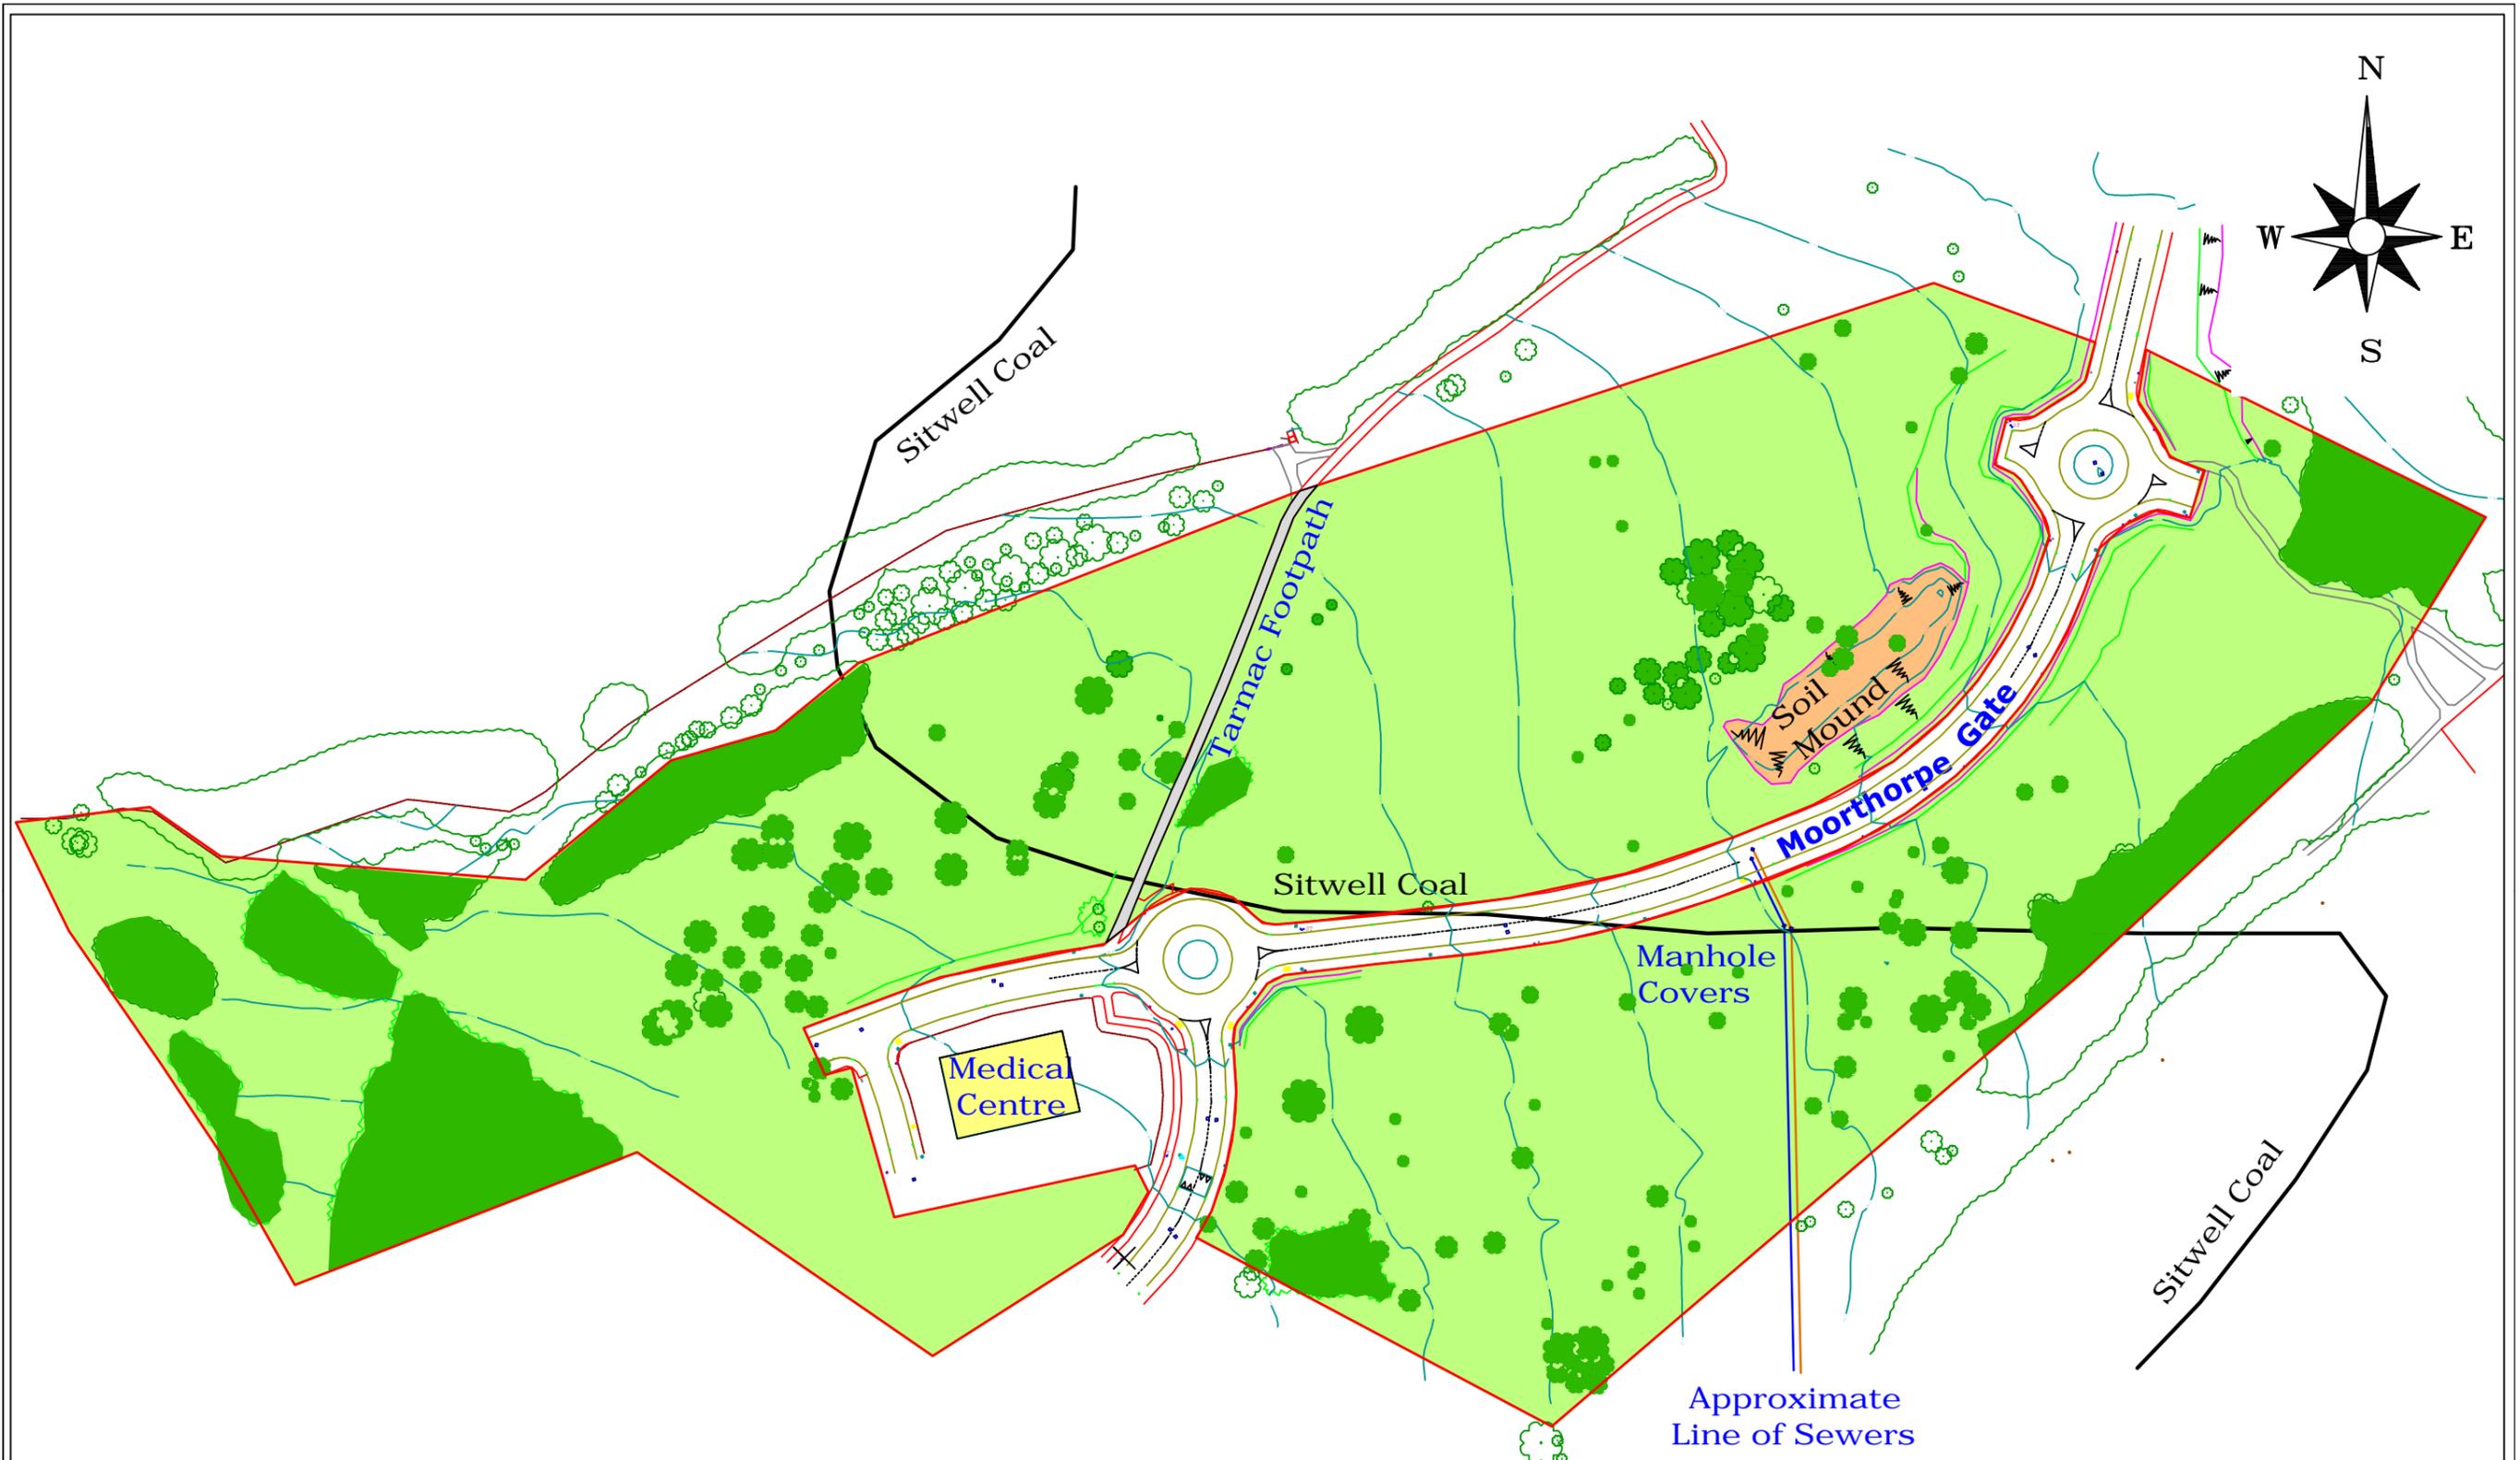
<b>DRAWN</b> ASw	<b>DATE</b> 15 01 14
<b>APPROVED</b> REG	<b>DATE</b> 15 01 14
<b>SCALE</b> 1:1,500	<b>SHEET</b> A3
<b>DRAWING NO.</b> 1792/3	<b>REVISION</b>

The site comprises two separate areas of rough grassed undulating land, with localised areas of copse and bushes, divided north and south by Moorthorpe Gate. The northern area slopes steadily down to the east with a steep slope on the eastern boundary where re-grading works are likely to have taken place during construction of a roundabout on Moorthorpe Gate.

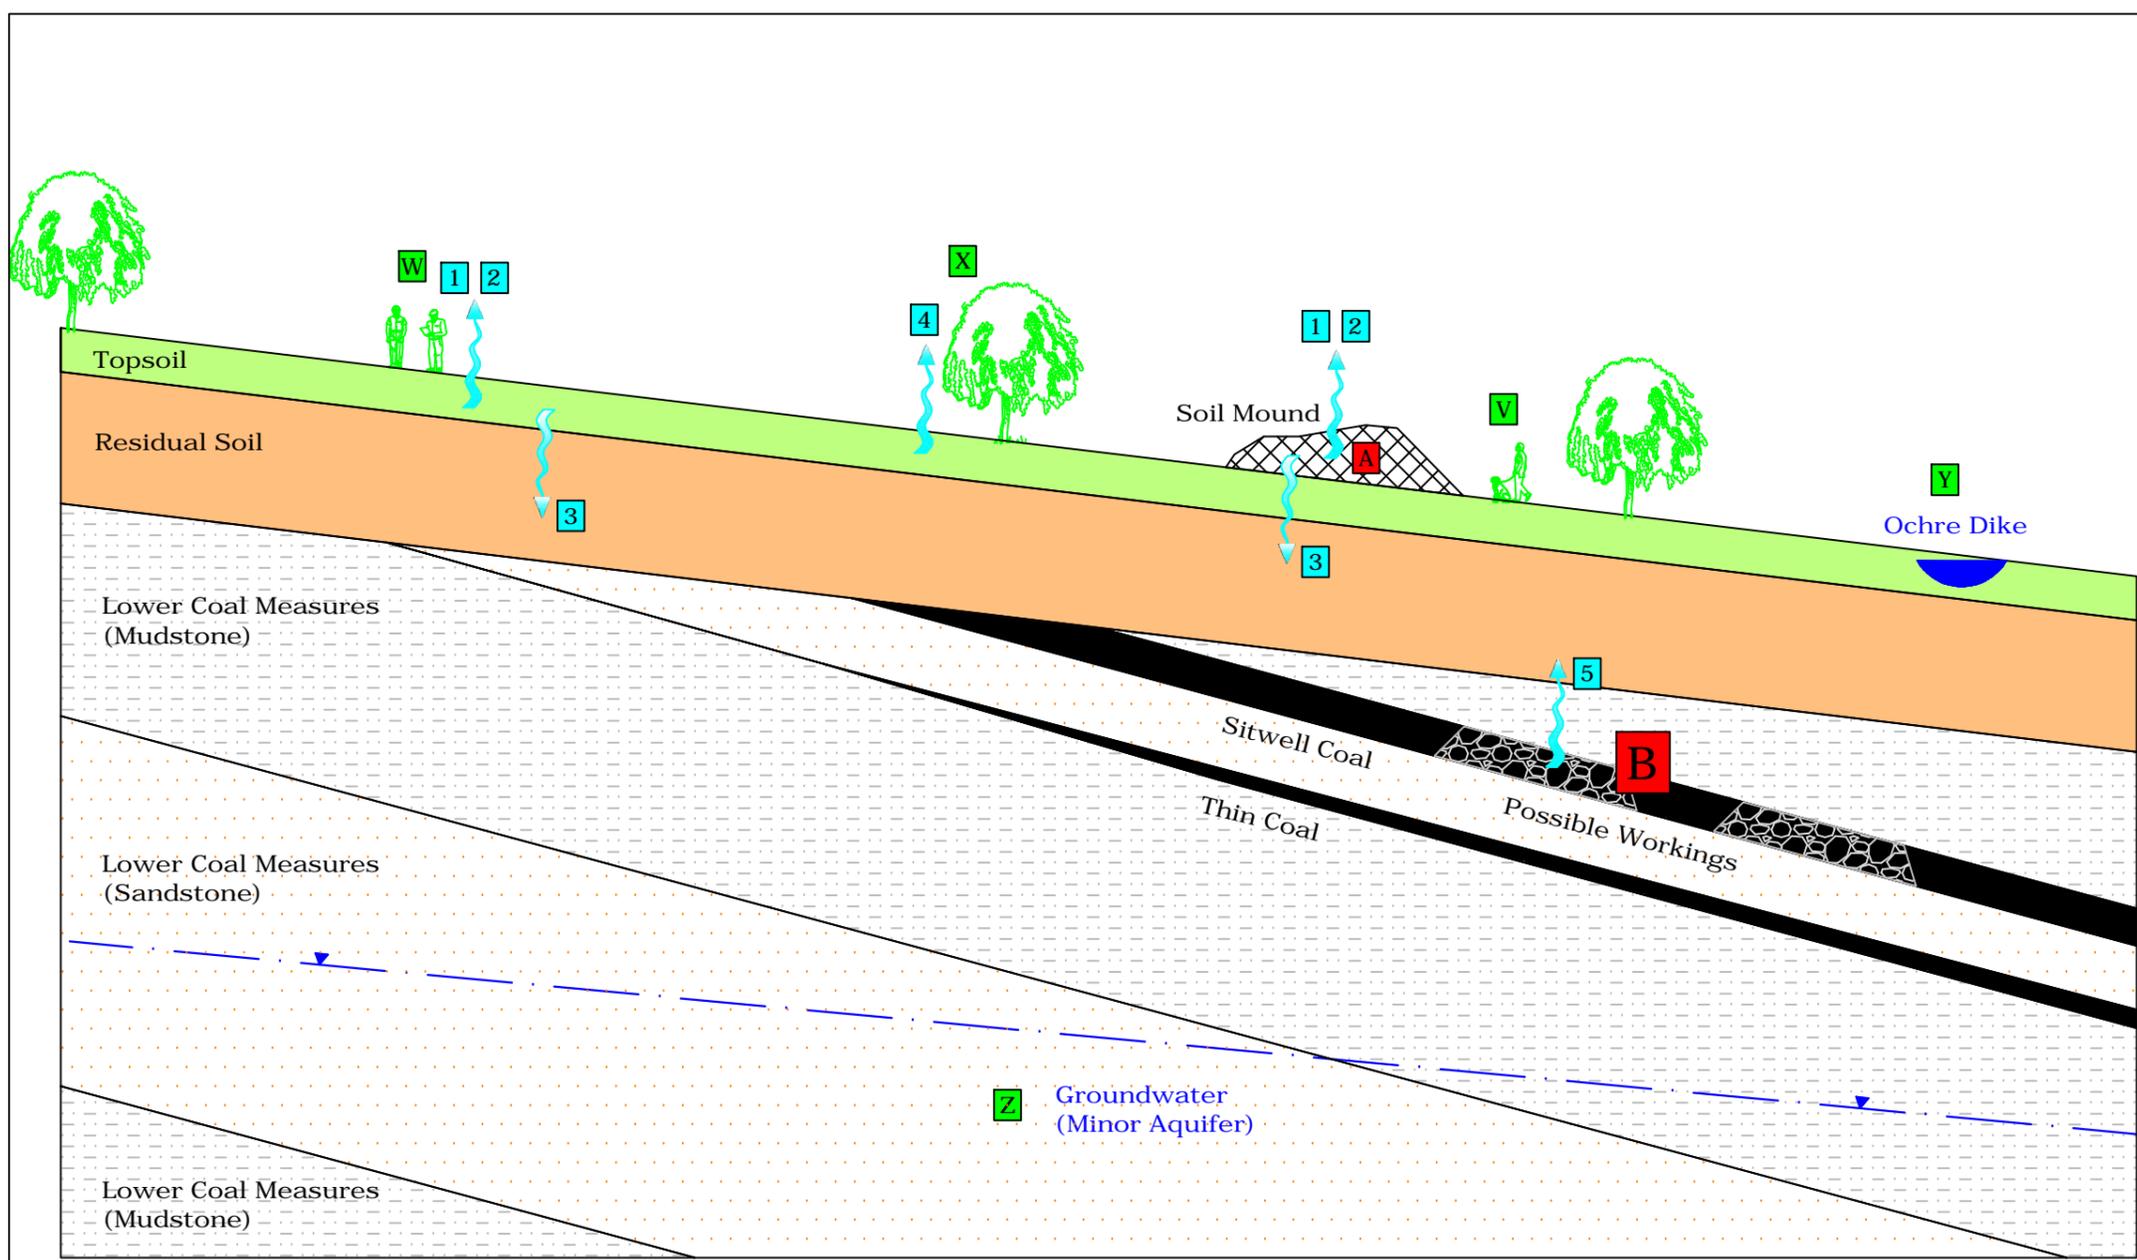
**PRELIMINARY CONCEPTUAL SITE MODEL**

SOURCES	
<b>A</b>	MADE GROUND (INORGANICS)
<b>B</b>	MINEWORKINGS (GAS)

PATHWAYS	
<b>1</b>	DERMAL CONTACT
<b>2</b>	INGESTION\INHALATION
<b>3</b>	LEACHING OF CONTAMINANTS
<b>4</b>	UPTAKE BY PLANTS
<b>5</b>	MIGRATION OF GAS

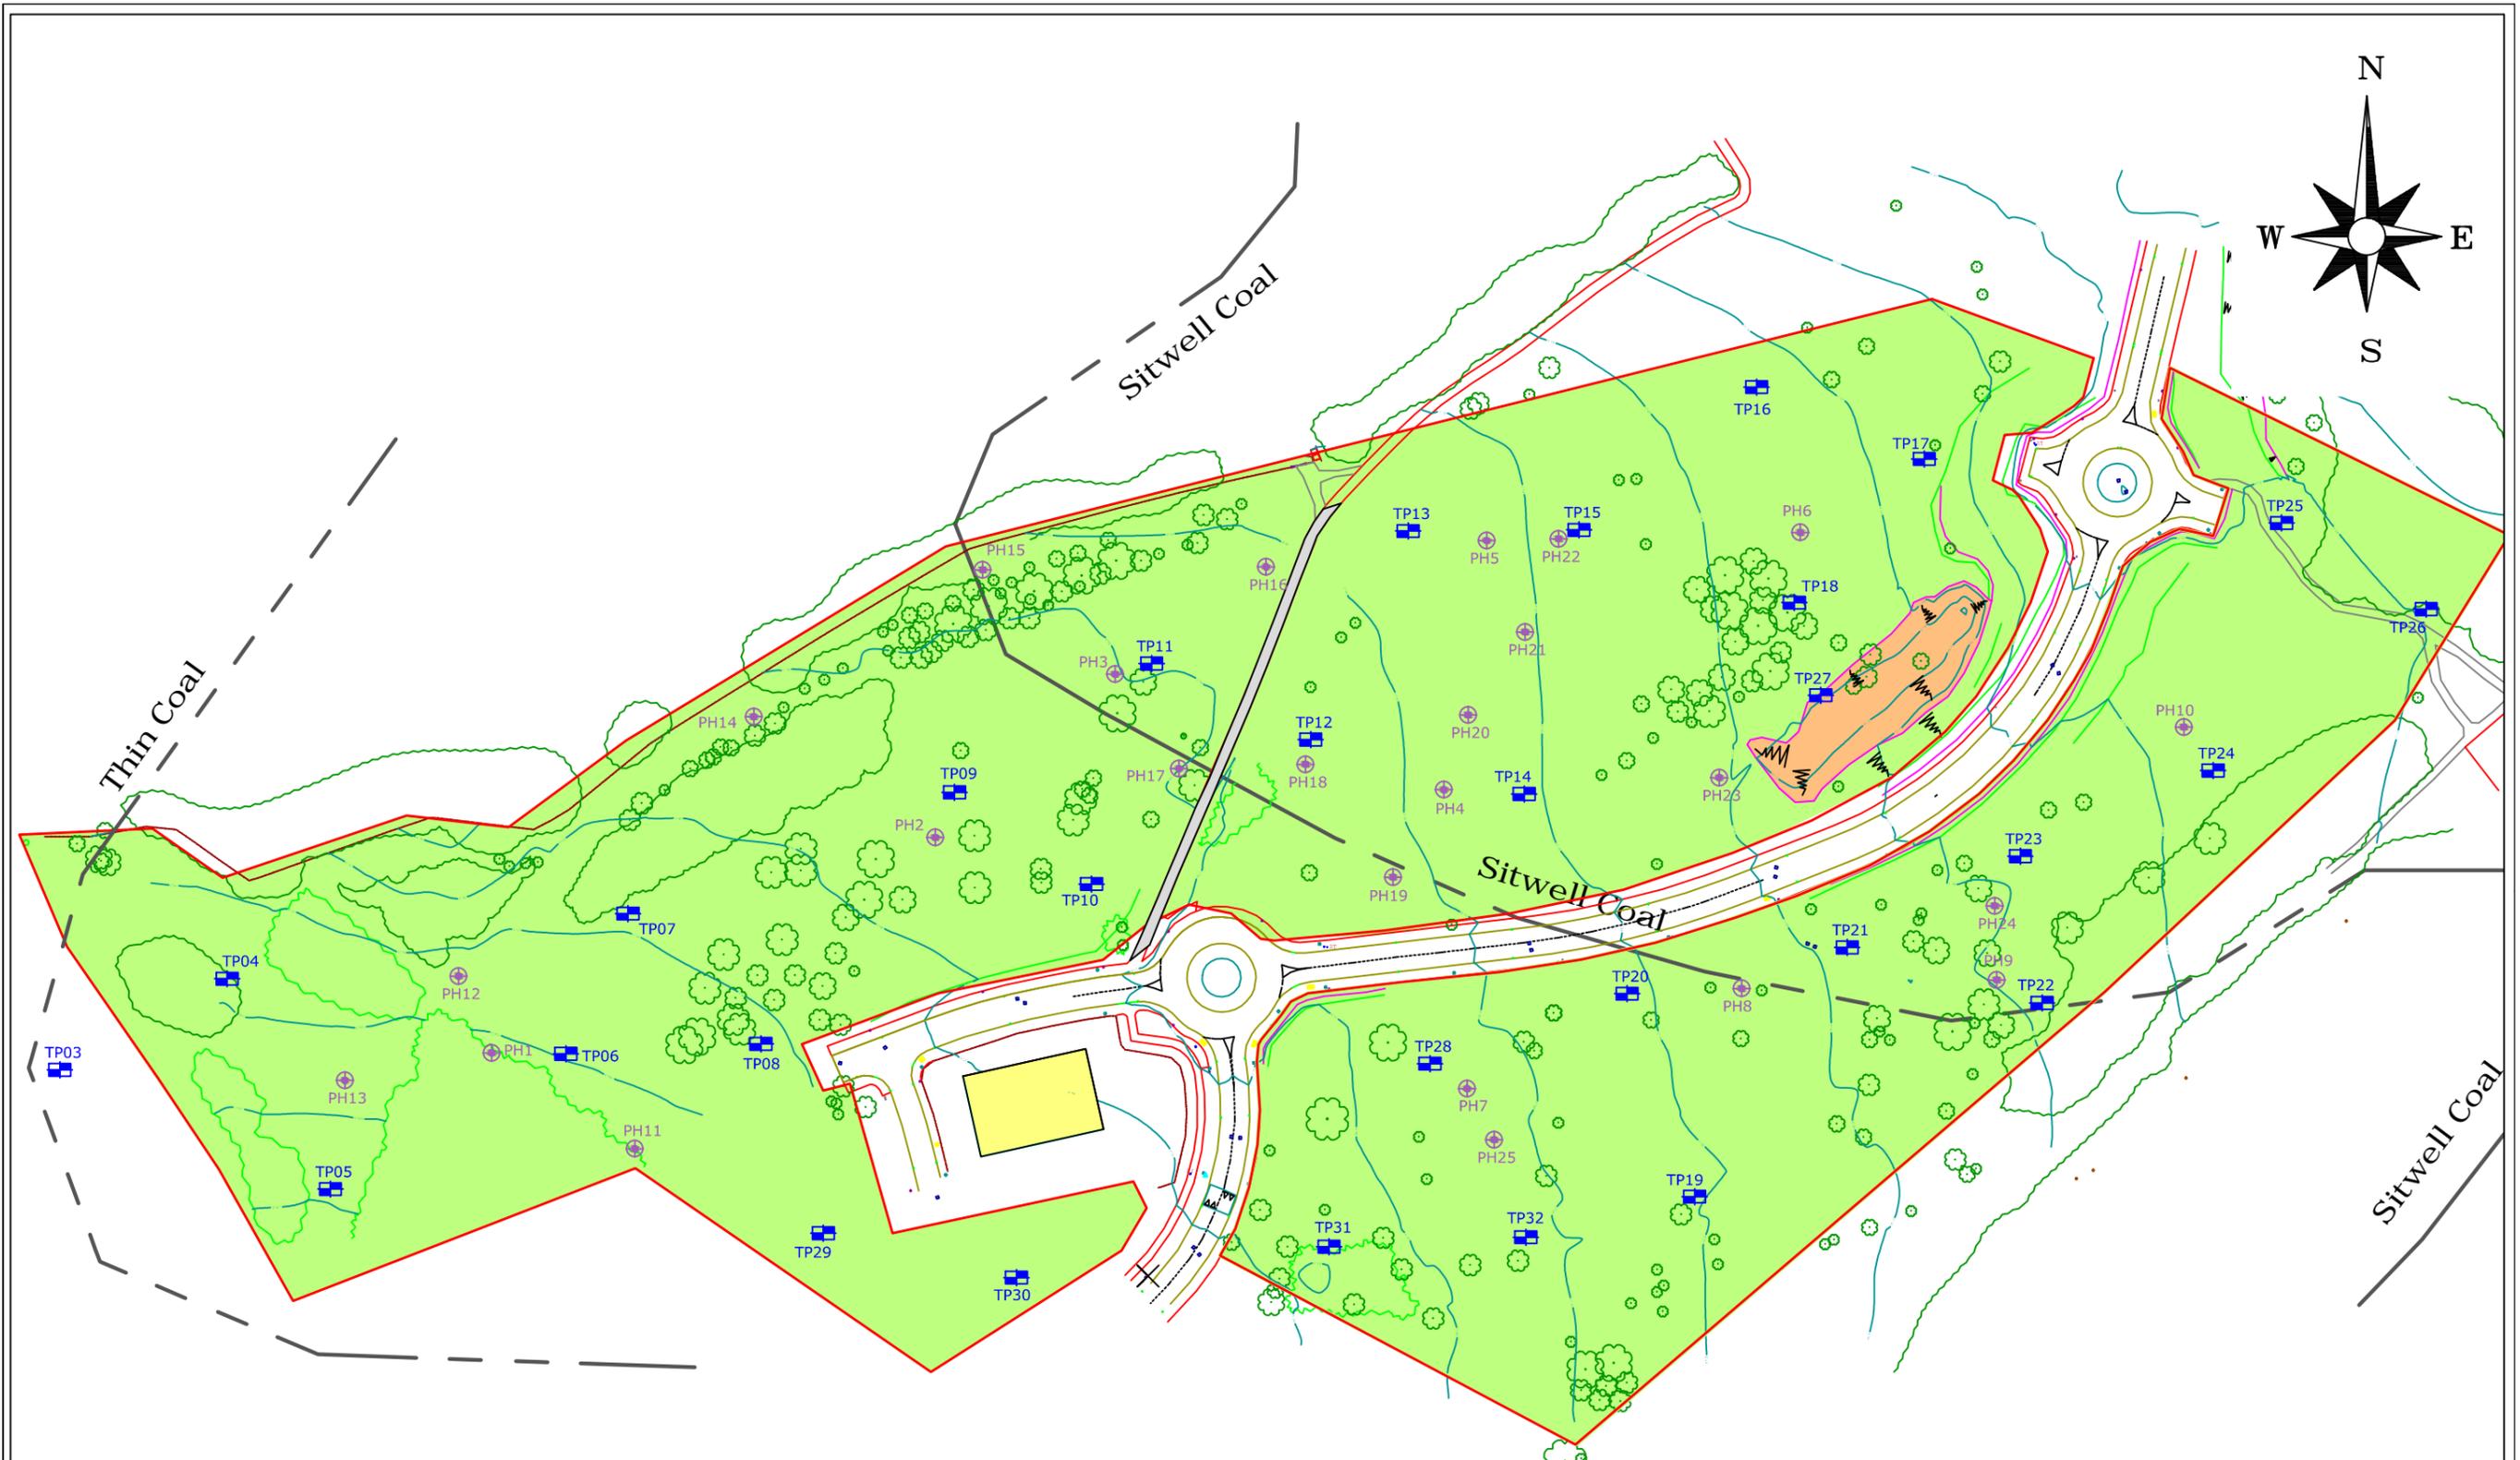
REV.	DESCRIPTION	DATE
B	ADDITIONAL PROBEHOLE LOCATIONS ADDED (PH11 TO PH25)	13 03 14

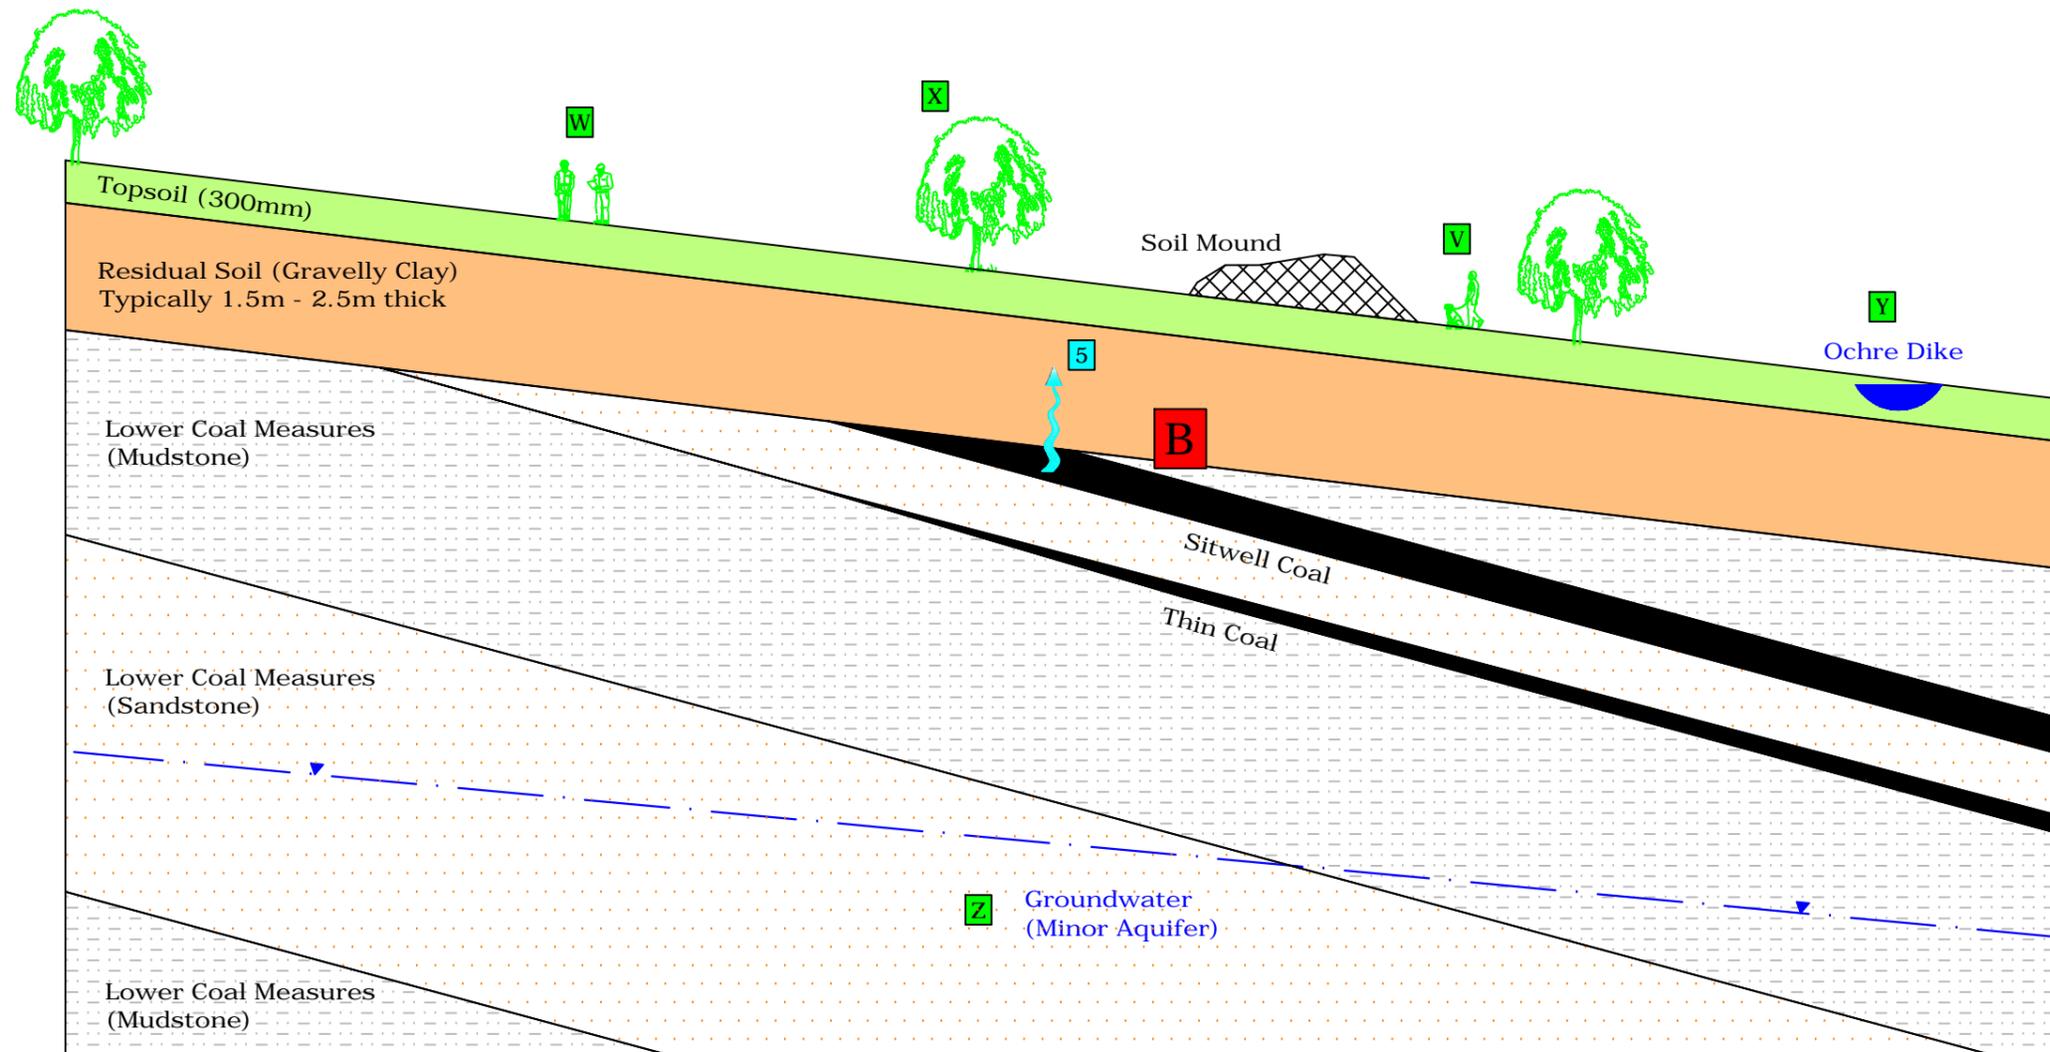
SOURCES	
<b>B</b>	SHALLOW COAL (GAS)

PATHWAYS	
<b>5</b>	MIGRATION OF GAS

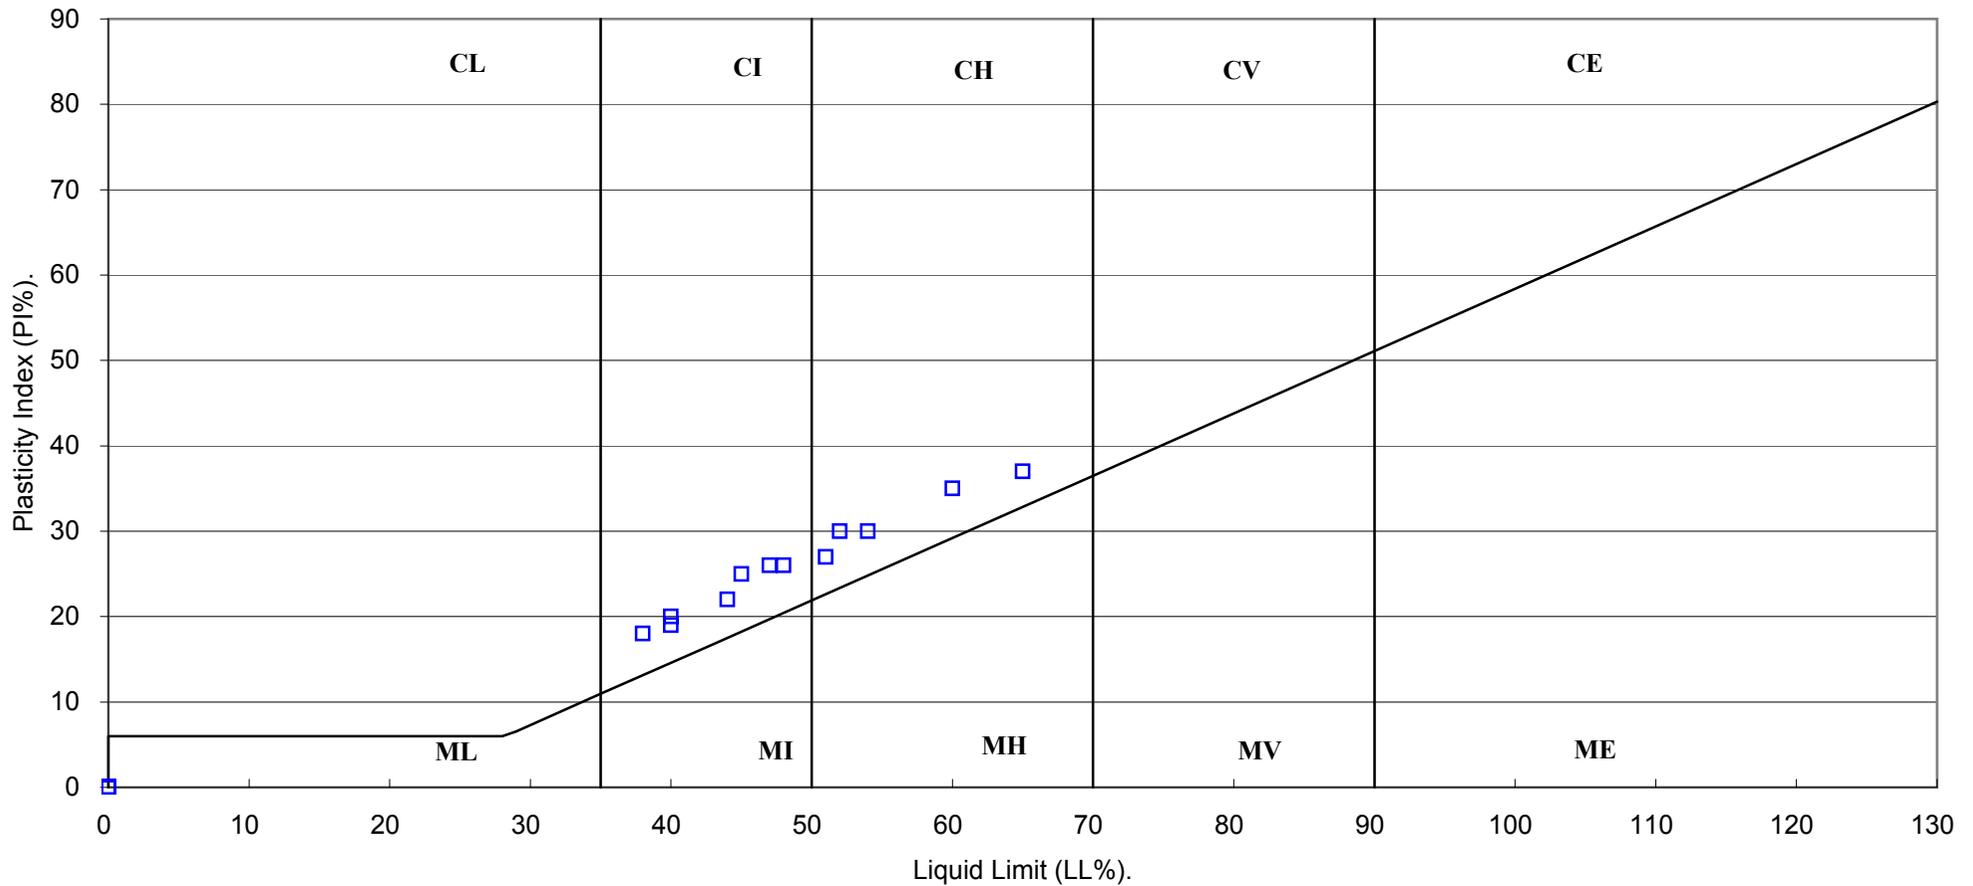
# PLASTICITY CHART FOR CASAGRANDE CLASSIFICATION.

(B.S.5930 : 1999)

- 11.2.2 For the purposes of foundation design, it is recommended that all cohesive soils be regarded as being of medium shrinkability.
