KEEPMOAT HOMES

**EAKRING ROAD,
BILSTHORPE**

**GEO-ENVIRONMENTAL
ASSESSMENT REPORT**

Project title: **Eakring Road, Bilsthorpe**
 Document type: **Geo-Environmental Assessment Report**
 Job number: **19017**

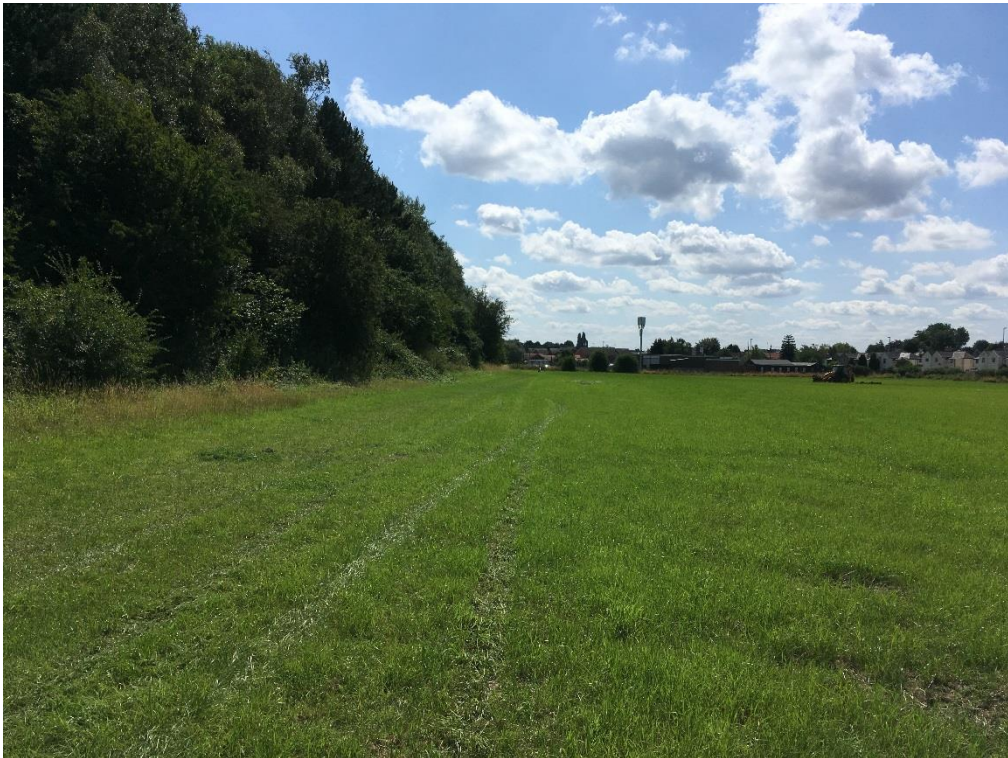
Looking south at eastern boundary and bank

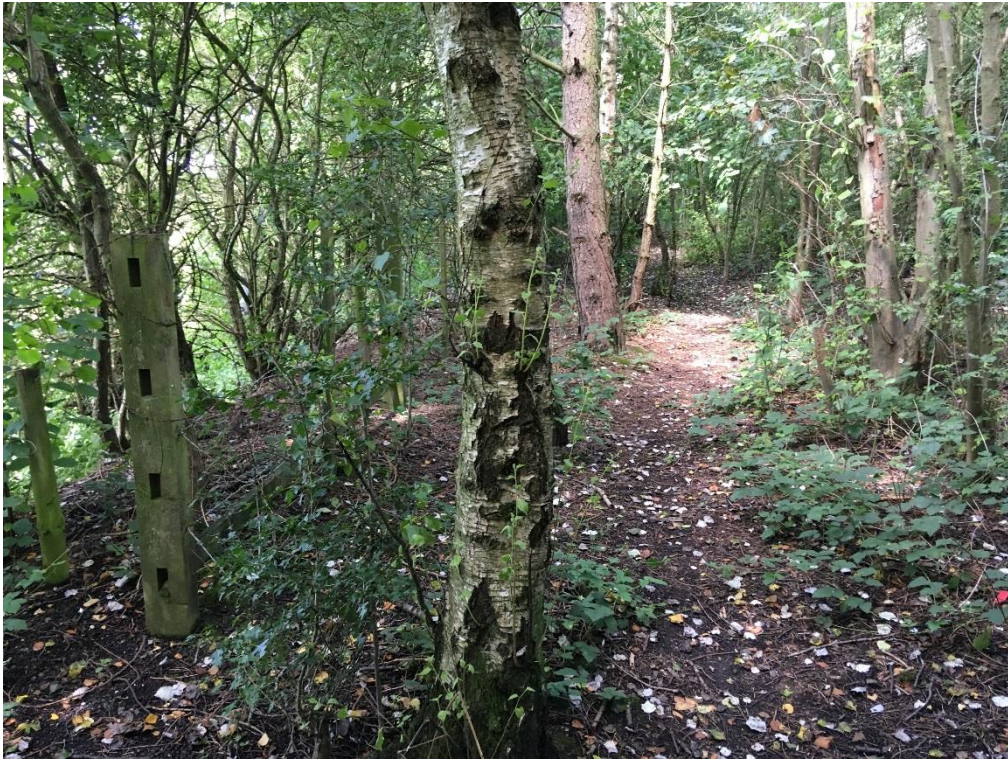
Raised bank in south east of the site

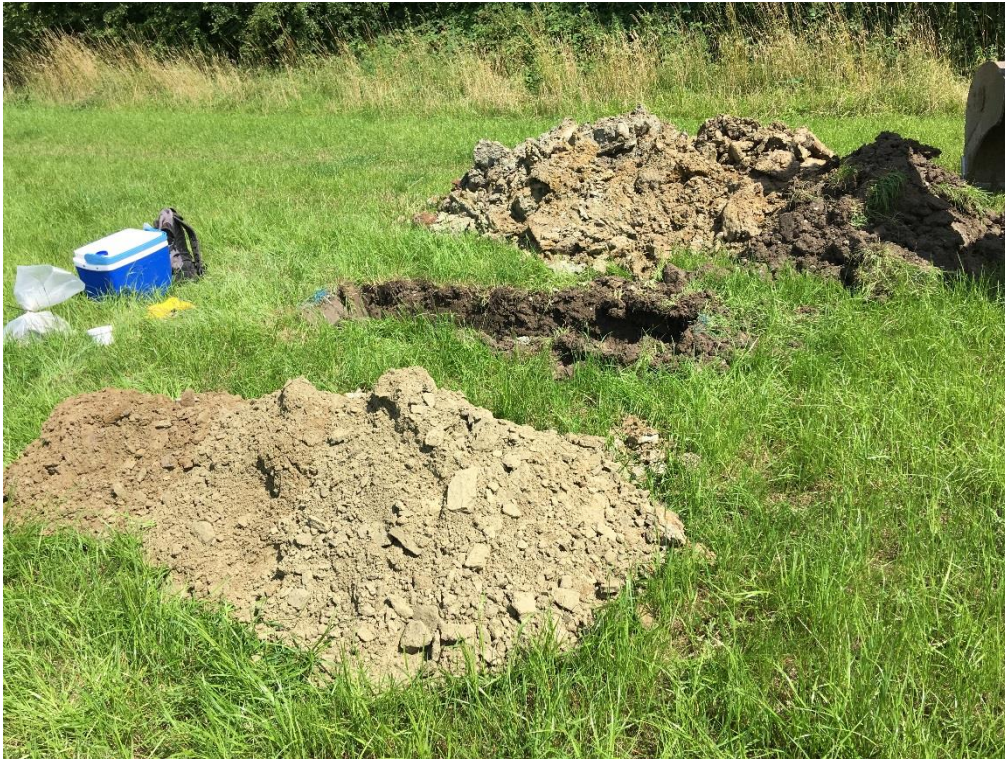
Spoil heap of TP07 showing siltstone of the Retford Member encountered at base

with observed lithorelicts. At the base of the aforementioned locations, fragments of extremely weak green-grey siltstone were encountered. These materials are considered to be representative of weathered strata of the Retford Member which is recorded to underlie the eastern part of the site. Drilling at DS03 and DS06 refused between 1.52m and 2.00m below ground level.

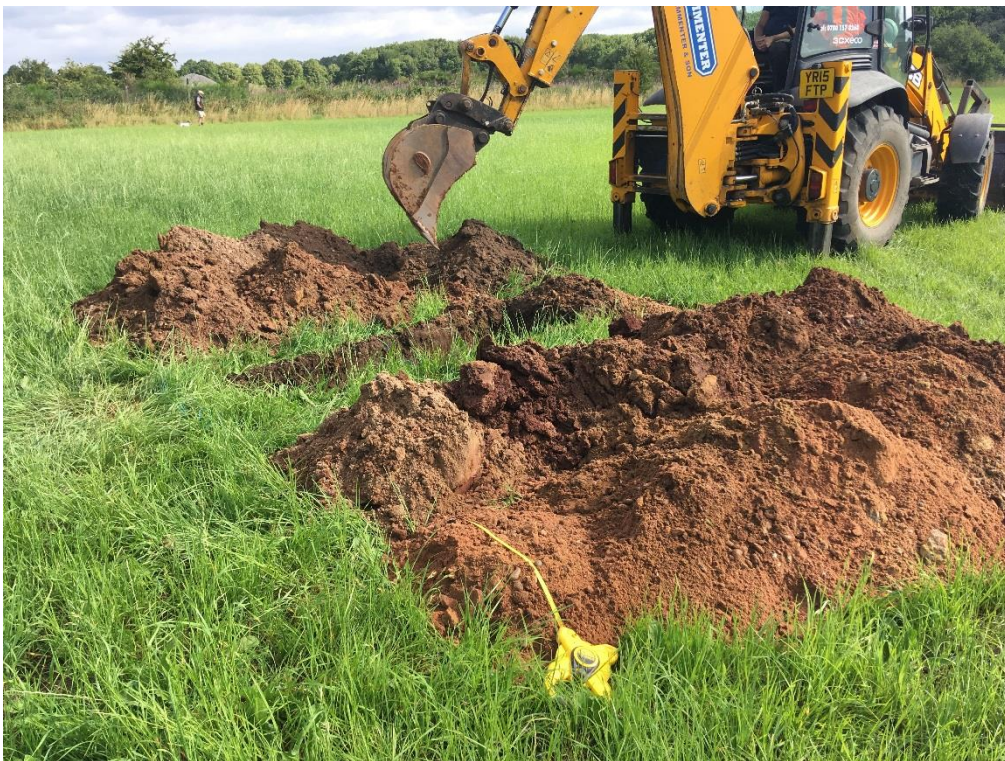
Spoil heap of TP01 showing weathered sands of the Chester Formation

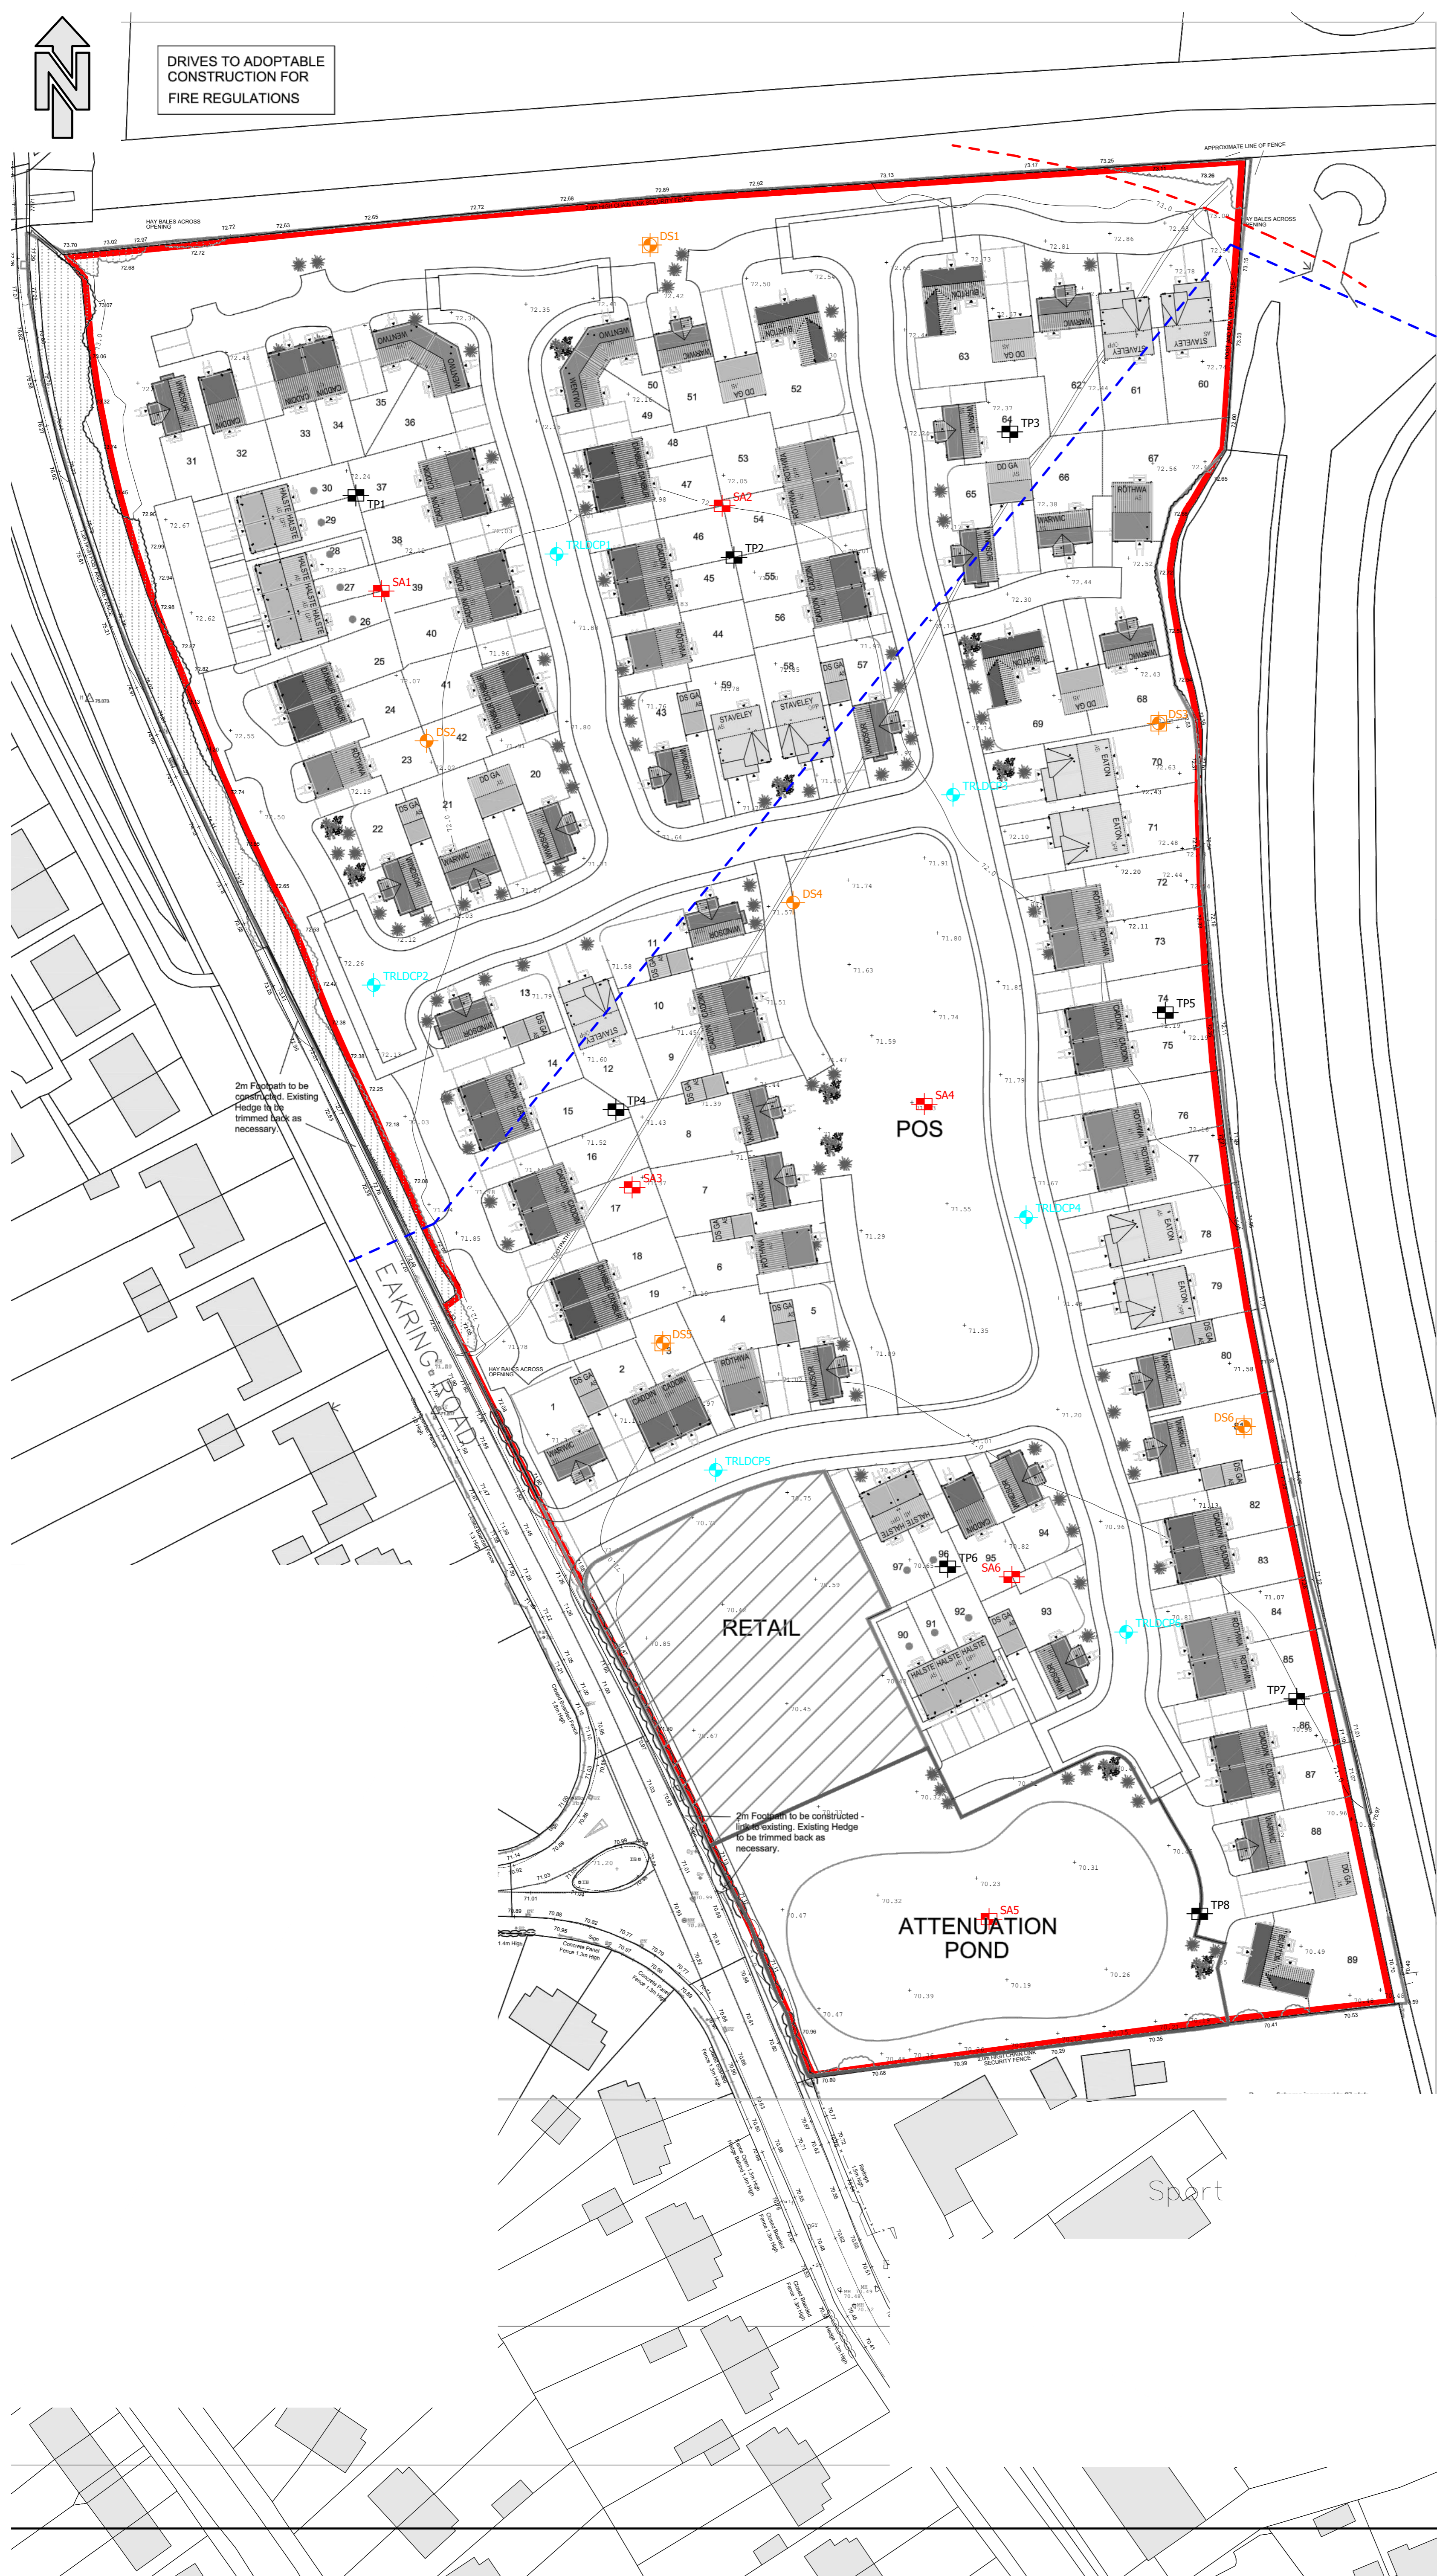
- TP8 TRIAL PIT LOCATION
- SA6 SOAKAWAY LOCATION
- TRLDPC6 DYNAMIC CONE PENETROMETER LOCATION
- DS4 DYNAMIC SAMPLE LOCATION
- DS6 BOREHOLE WITH GAS MONITORING STANDPIPE
- SITE BOUNDARY
- RECORDED WATER MAIN
- UNDERGROUND ELECTRICITY CABLE

- 1.1.6 Initial site investigations were undertaken at the Eakring Road site on the 29 July 2019, which comprised the drilling of six dynamic sampling boreholes, six TRL probes and eight machine excavated trial pits. The dynamic sampling boreholes and the TRL probes were completed by Exploration Ltd. The trial pits were undertaken by St. Clements Plant Ltd. Subsequent to the initial site investigation works, six soakaway tests were undertaken across the site. The investigations were completed under the direct supervision of Travis Baker Geo-Environmental Ltd. The locations of the exploratory holes are illustrated on Drawing No. 19017-GE01.
