Appendix 2 – White Clawed Crayfish, Otter & Watervole Report

Land off Carr Road, Deepcar

WATER VOLE, OTTER & WHITE CLAWED CRAYFISH REPORT

June 2018

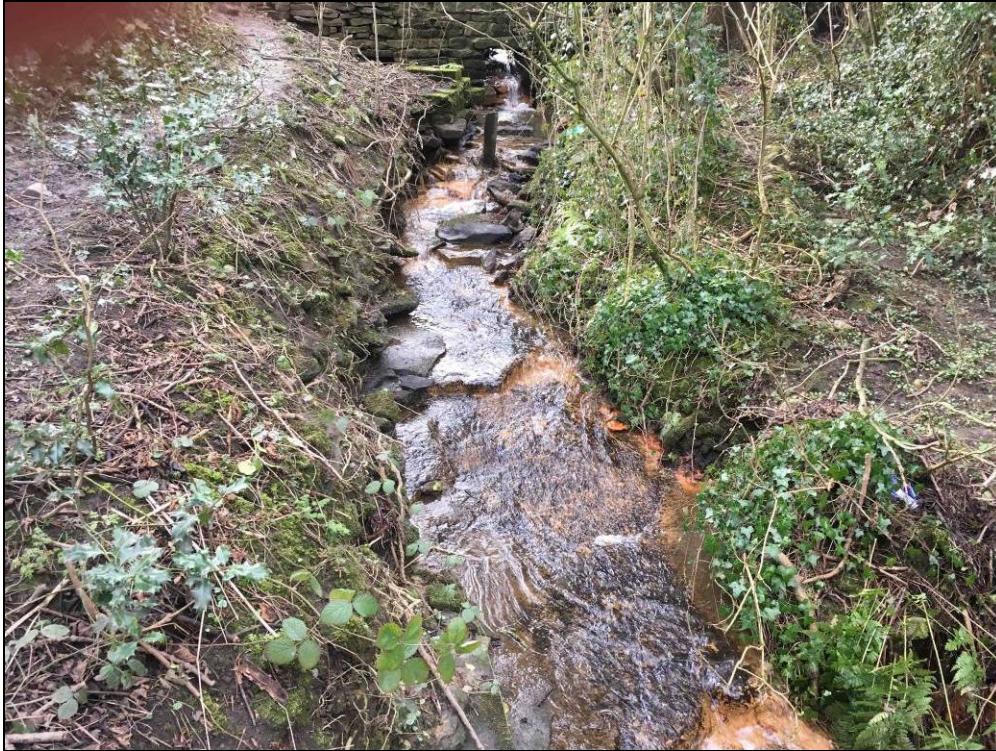
Plate 3: Habitat 3.

- Habitat 3: Approximately 30m from the source to downstream and within the central area of the water course. The watercourse was approximately 5cm deep and 0.5-1m wide. Water flow would be described as glide with substrate of bedrock, with very few boulders. The banks were steep and comprised of rocks, ivy, bramble and moss. There was approximately 75% shading over the water column. There were a few undercut banks.
