Appendix 4 – Water Framework Directive (Screening) Assessment

Hallam Land Management Ltd.

Land at Carr Road, Deepcar, Sheffield

WATER FRAMEWORK DIRECTIVE ASSESSMENT

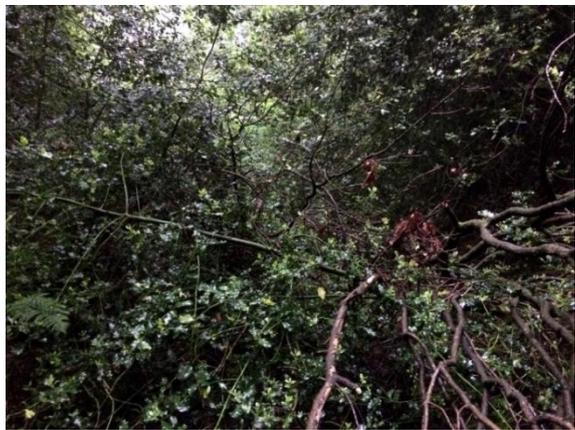
<p style="text-align: center;">Photograph 1</p>

Description	Photograph
A canopy of shrubs cover most of the brook bed where it issues (Photograph 1.).

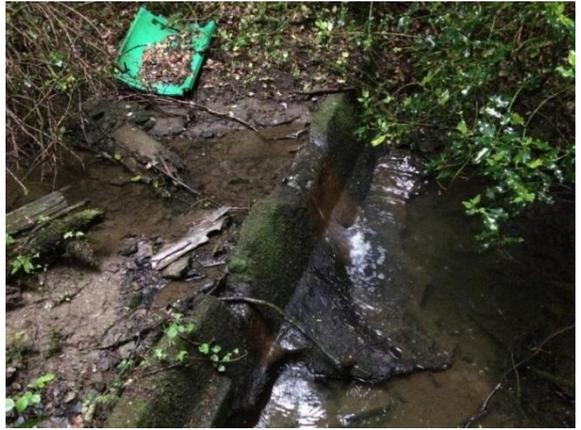
<p style="text-align: center;">Photograph 2</p>
<p>Beyond these structures the channel widens to approximately 3m and the right bank has been reinforced but slightly further downstream after a stretch of medium-sized cobbles an unvegetated point bar (Photograph 3) is present</p>

Description	Photograph
<p>This cover eventually opens out and the stream flows over two small artificial weirs (Photograph 2)</p>

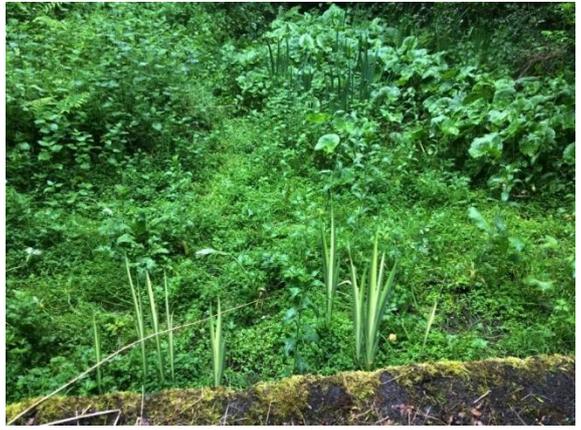
<p style="text-align: center;">Photograph 4)</p>

<p style="text-align: center;">Photograph 3</p>
<p>The stream then flows into an area of swamp with abundant to dominant marsh marigold <i>Caltha palustris</i>, abundant opposite-leaved golden-saxifrage, <i>Chrysosplenium oppositifolium</i> frequent yellow iris <i>Iris pseudacorus</i> (and more rarely a variegated hortical variety), occasional great willowherb <i>Epilobium hirsutum</i>, creeping buttercup <i>Ranunculus repens</i>, broad-leaved dock <i>Rumex obtusifolius</i> and wavy bitter-cress <i>Cardamine flexuosa</i> and small amounts of bog stitchwort <i>Stellaria alsine</i>. This area was previously a pool for swimming which had been constructed across the channel. (Photograph 4)</p>

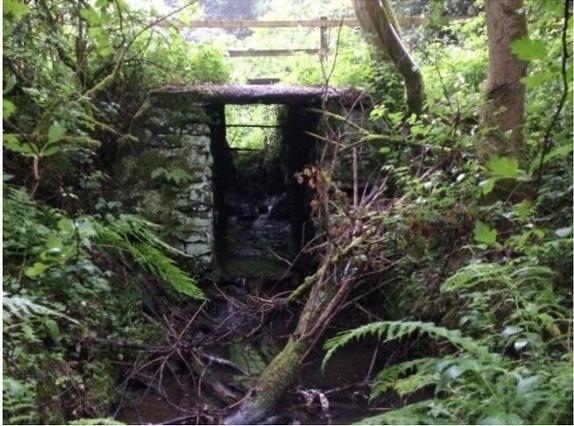
<p style="text-align: center;">Photograph 5</p>
<p>Downstream of the bridge the channel is approximately 2m wide and the substrate is formed by large moss-covered cobbles which form a gentle rocky cascade (Photograph 6). Small sections of the bank have been reinforced.</p>

Description	Photograph
<p>Immediately downstream of this the stream flows beneath a stone footbridge (Photograph 5)</p>

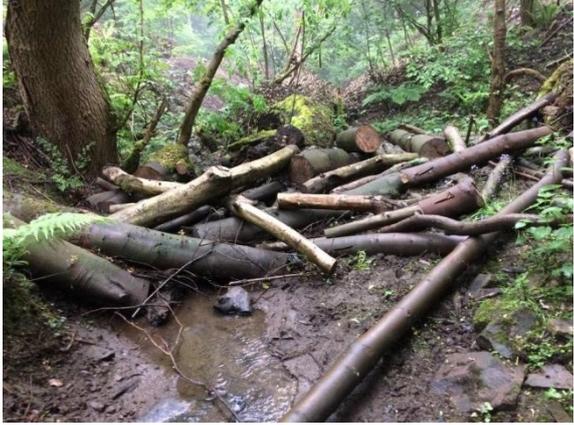
<p style="text-align: center;">Photograph 7</p>

<p style="text-align: center;">Photograph 6</p>
<p>A large, debris dam had recently been constructed across the channel (Photograph 7) after which the stream flows through a narrowed channel with steep banks which locally support stands of bryophytes</p>

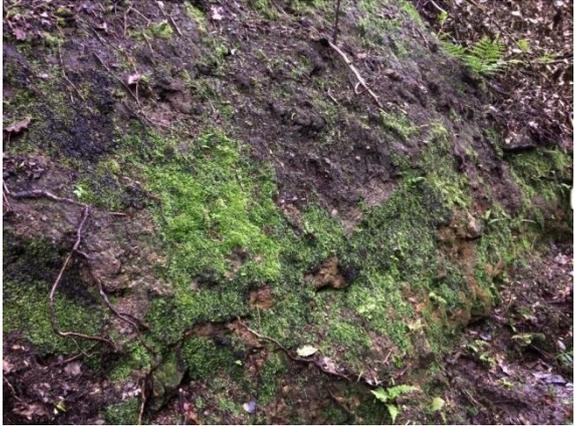
<p style="text-align: center;">Photograph 8</p>
<p>Downstream of the dam the channel is formed by a short stretch of rocky cascade (Photograph 9) before changing to a channel substrate formed by bedrock with a shallow thin flow. Here the channel is approximately 1.5m wide.</p>

Description	Photograph
<p>A second recently constructed debris dam soon appears and beyond this the channel flows through an S-bend and here the clay banks (Photograph 8) become vertical and support abundant <i>Pellia Pellia</i> sp. and frequent notched pouchwort <i>Calypogeia arguta</i> with some young hard-fern <i>Blechnum spicant</i>.</p>

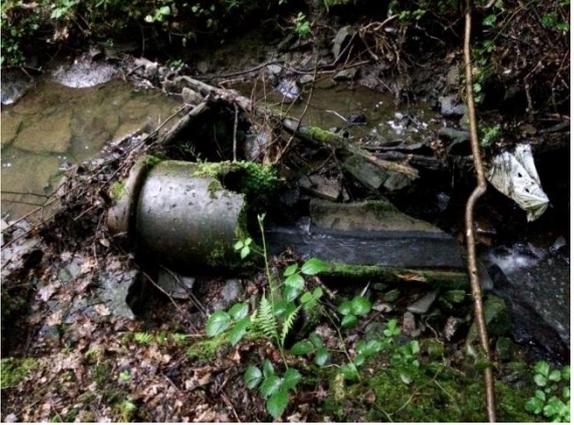
<p style="text-align: center;">Photograph 10</p>

<p style="text-align: center;">Photograph 9</p>
<p>Approaching the next debris dam there is a small unvegetated cobble point bar with an adjacent steep right bank. The channel then widens to approx. 3.5m. In this area there is an old pipe (Photograph 10) which is forming a small weir with an associated plunge pool and large fallen tree over the top of the pool.</p>

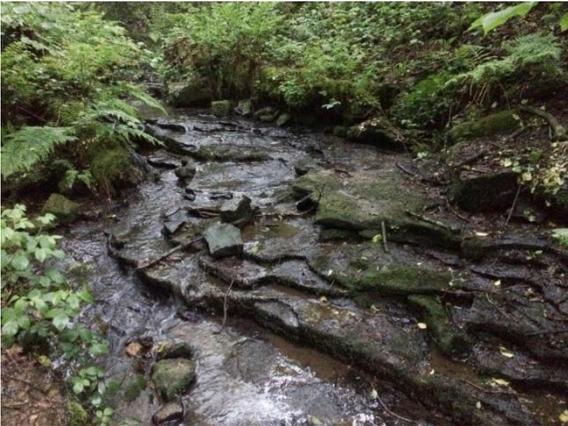
<p style="text-align: center;">Photograph 11</p>
<p>Downstream the stream flows through a man-made structure (Photograph 12) which was most likely the remnants of the old paddling pools, and there is then a small stone footbridge.</p>

Description	Photograph
<p>After this feature the stream flows through a very narrow channel less than 1m wide before widening over a bedrock substrate which forms a shallow stepped-weir (Photograph 11). The channel then widens further to approximately 4m with the substrate formed by bed-rock.</p>

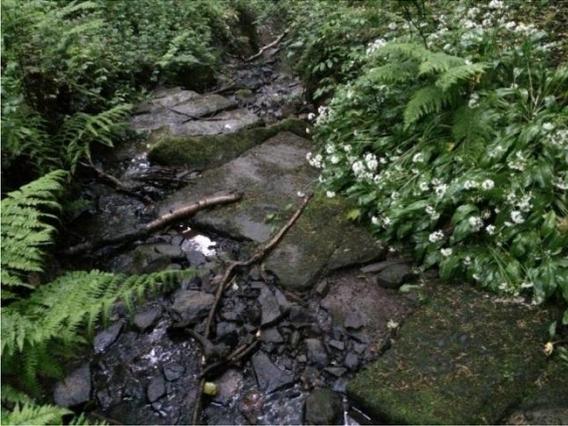
<p style="text-align: center;">Photograph 13</p>

<p style="text-align: center;">Photograph 12</p>
<p>Downstream of this there is again a small rocky cascade followed by a channel substrate formed by cobbles. Another man-made structure appears in the channel which then narrows to approximately 2m wide and the banks are reinforced, followed by a stretch (Photograph 13) where the channel substrate is formed by slabs of bedrock. The narrowed channel continues up to a small footbridge and in this area the banks have been reinforced with gabion baskets.</p>

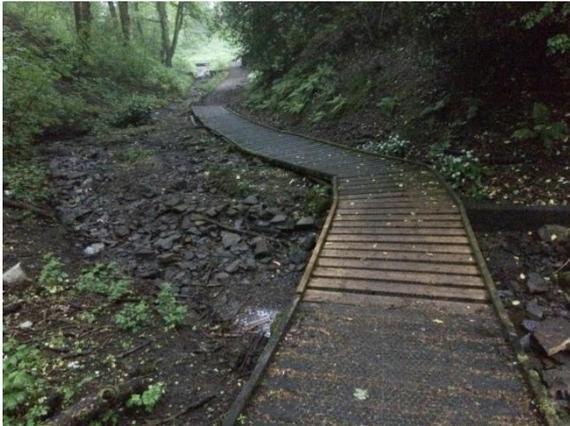
Description	Photograph
<p>Further downstream there is an adjacent boardwalk and the flow subsides to just a sparse flow over the cobble substrate.</p>

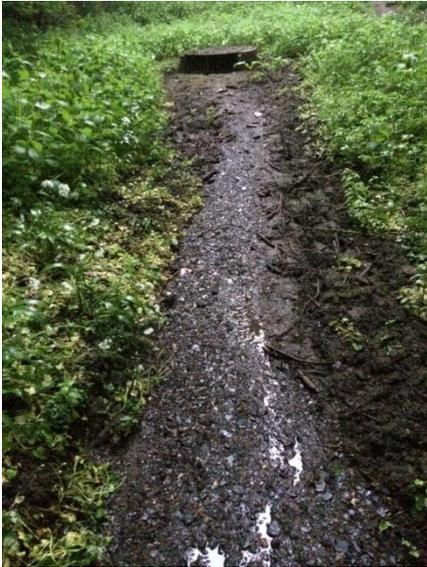
<p style="text-align: center;">Photograph 16</p>

<p style="text-align: center;">Photograph 15</p>
<p>A debris screen is located across the channel before a final straight run (Photograph 16) over a substrate approaching an outfall, beyond which the stream is culverted as it progresses towards its confluence with the Little Don. At the time of the survey this final stretch was dry.</p>

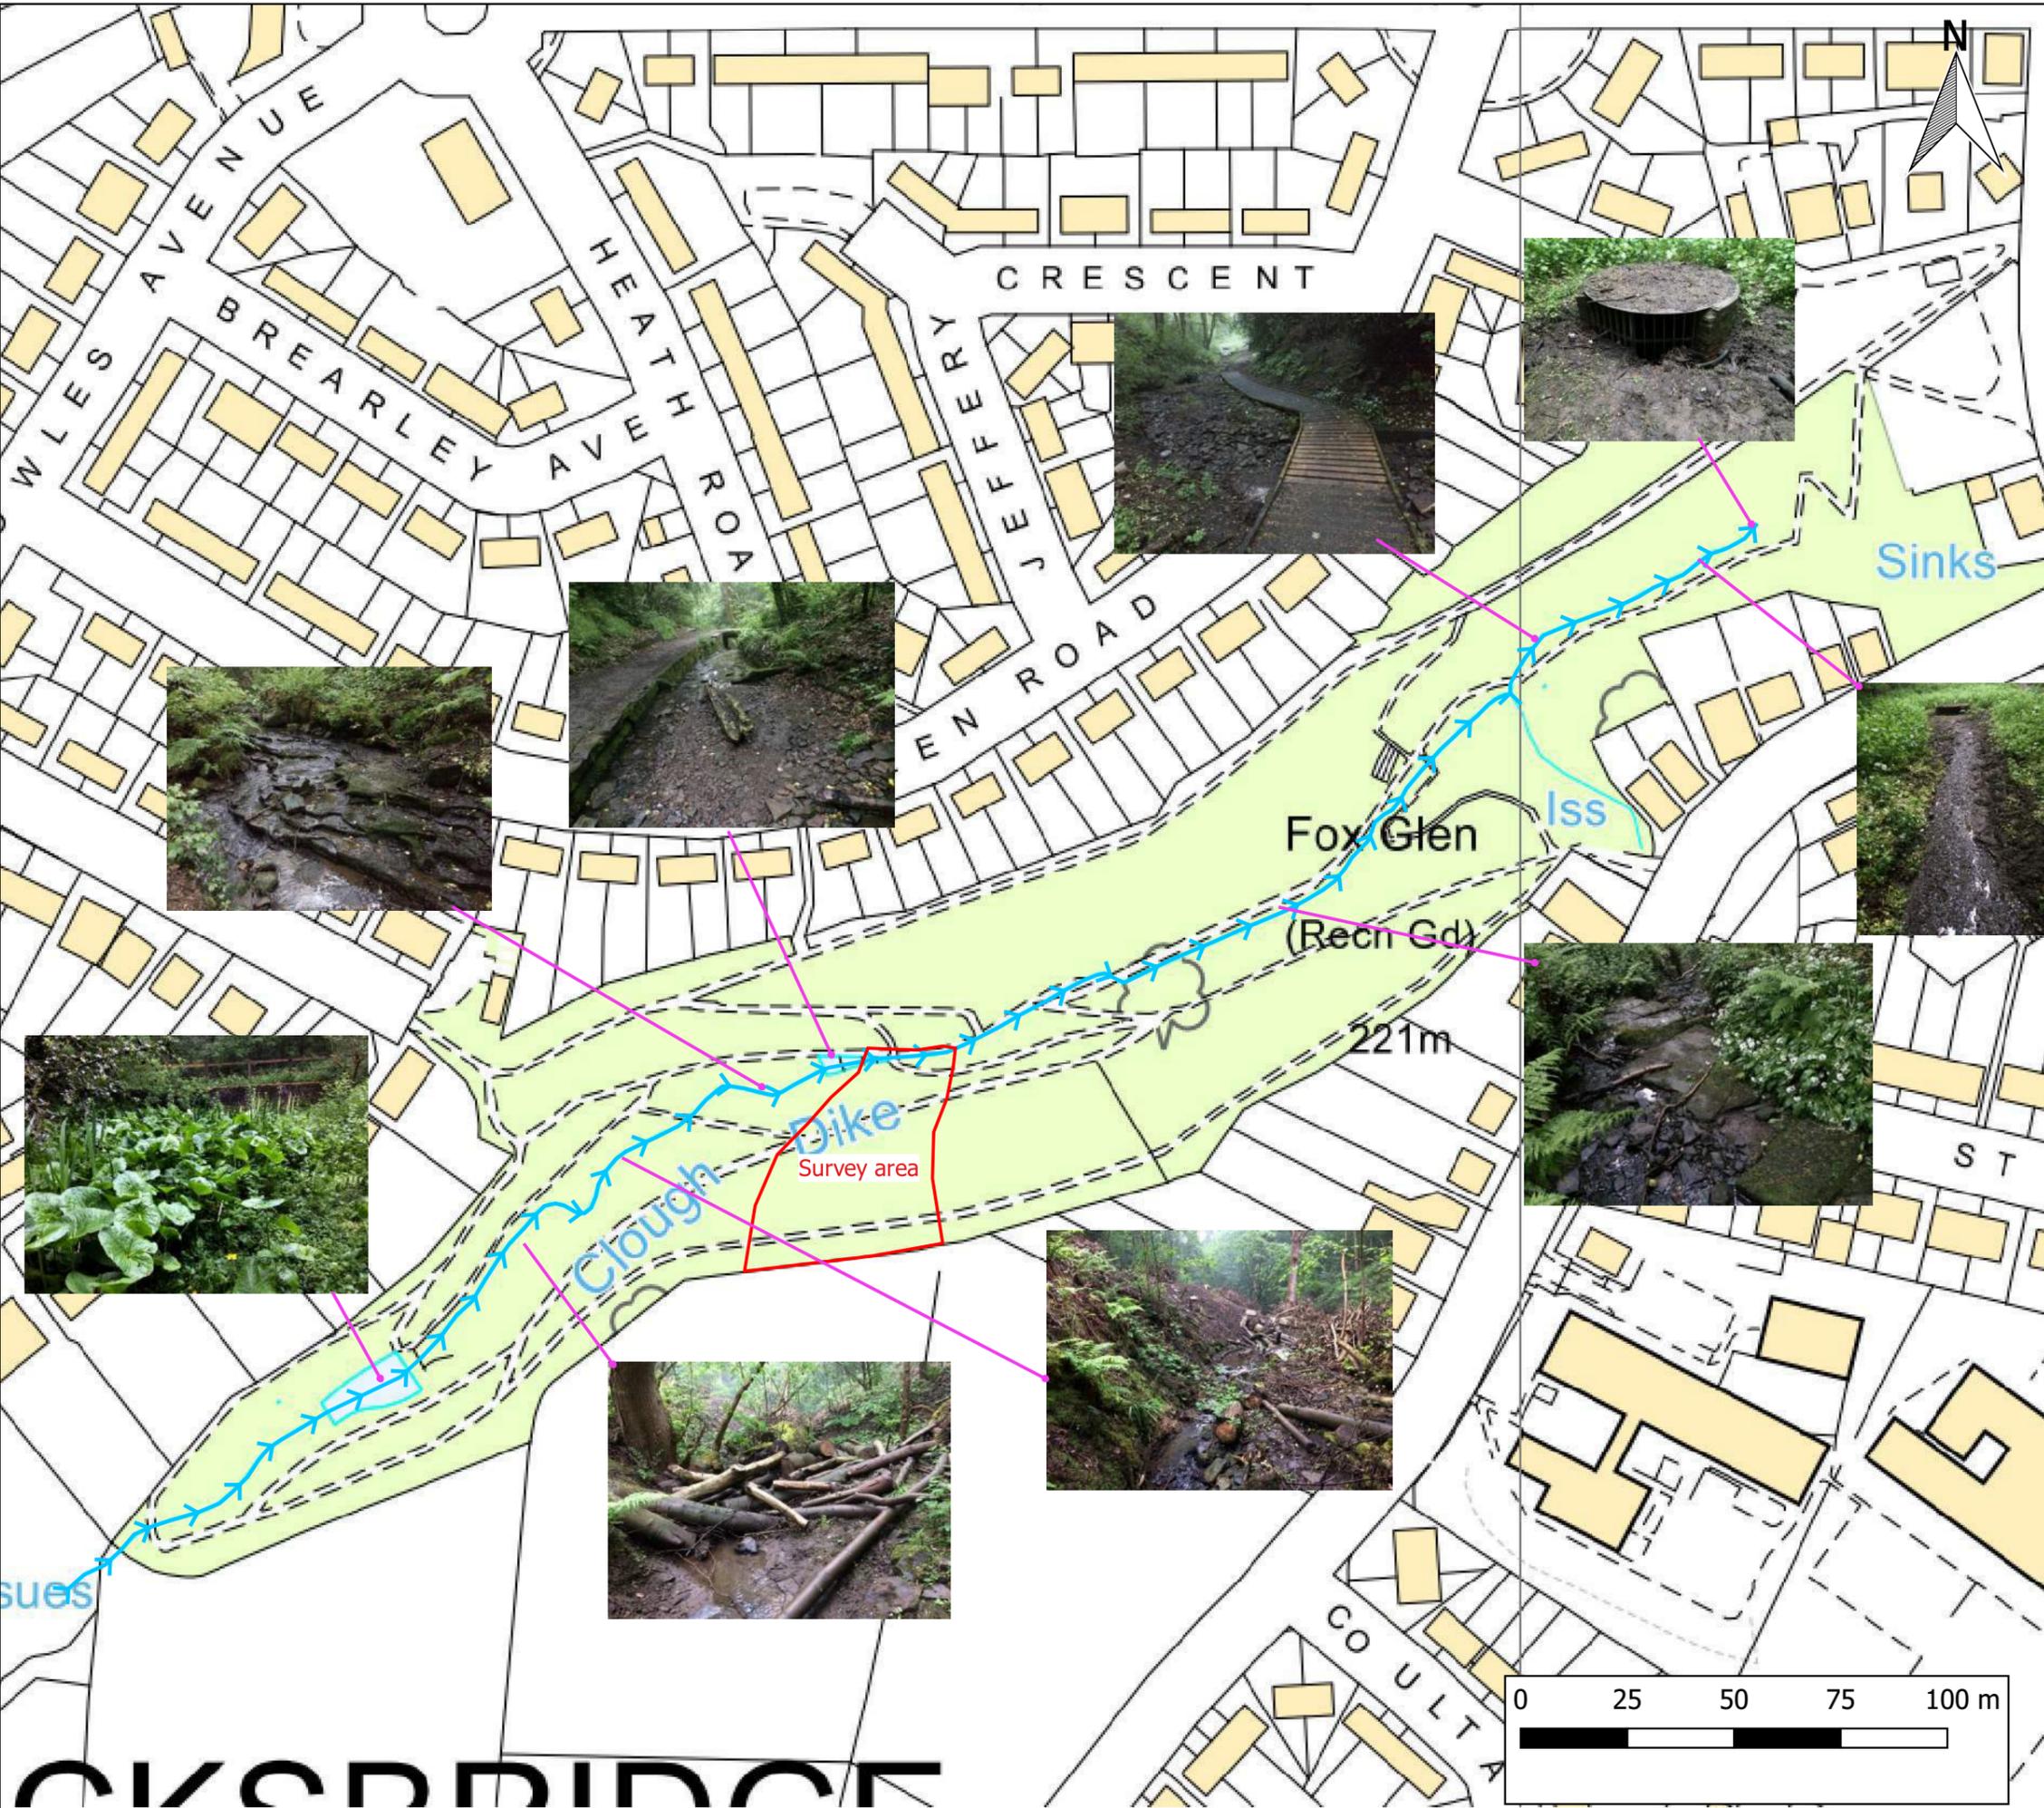
- Proposed location of drainage channel
- > Clough Dike

- 3.3 Since the FRA was published additional investigations have taken place to determine suitable options to achieve discharge into Clough Dike. Figure 1 shows the proposed location for the drainage channel. Two potential routes for the channel within this area were initially identified, one following a straight course, the other following a sinuous course; the final route is a hybrid design with a gently curving route. Various designs were considered for the type of structure needed to convey the water down the relatively steep banks of the Glen. The chosen design is an overland open channel filled with a rock cascade with a 6m wide maintenance easement. The cascade would be fed via a ductile iron pipe with an initial flow control at the head of the pipe to discharge water from a Sustainable Drainage Scheme (SuDS) attenuation basin. Figures 2 & 3 show the proposed design layout.

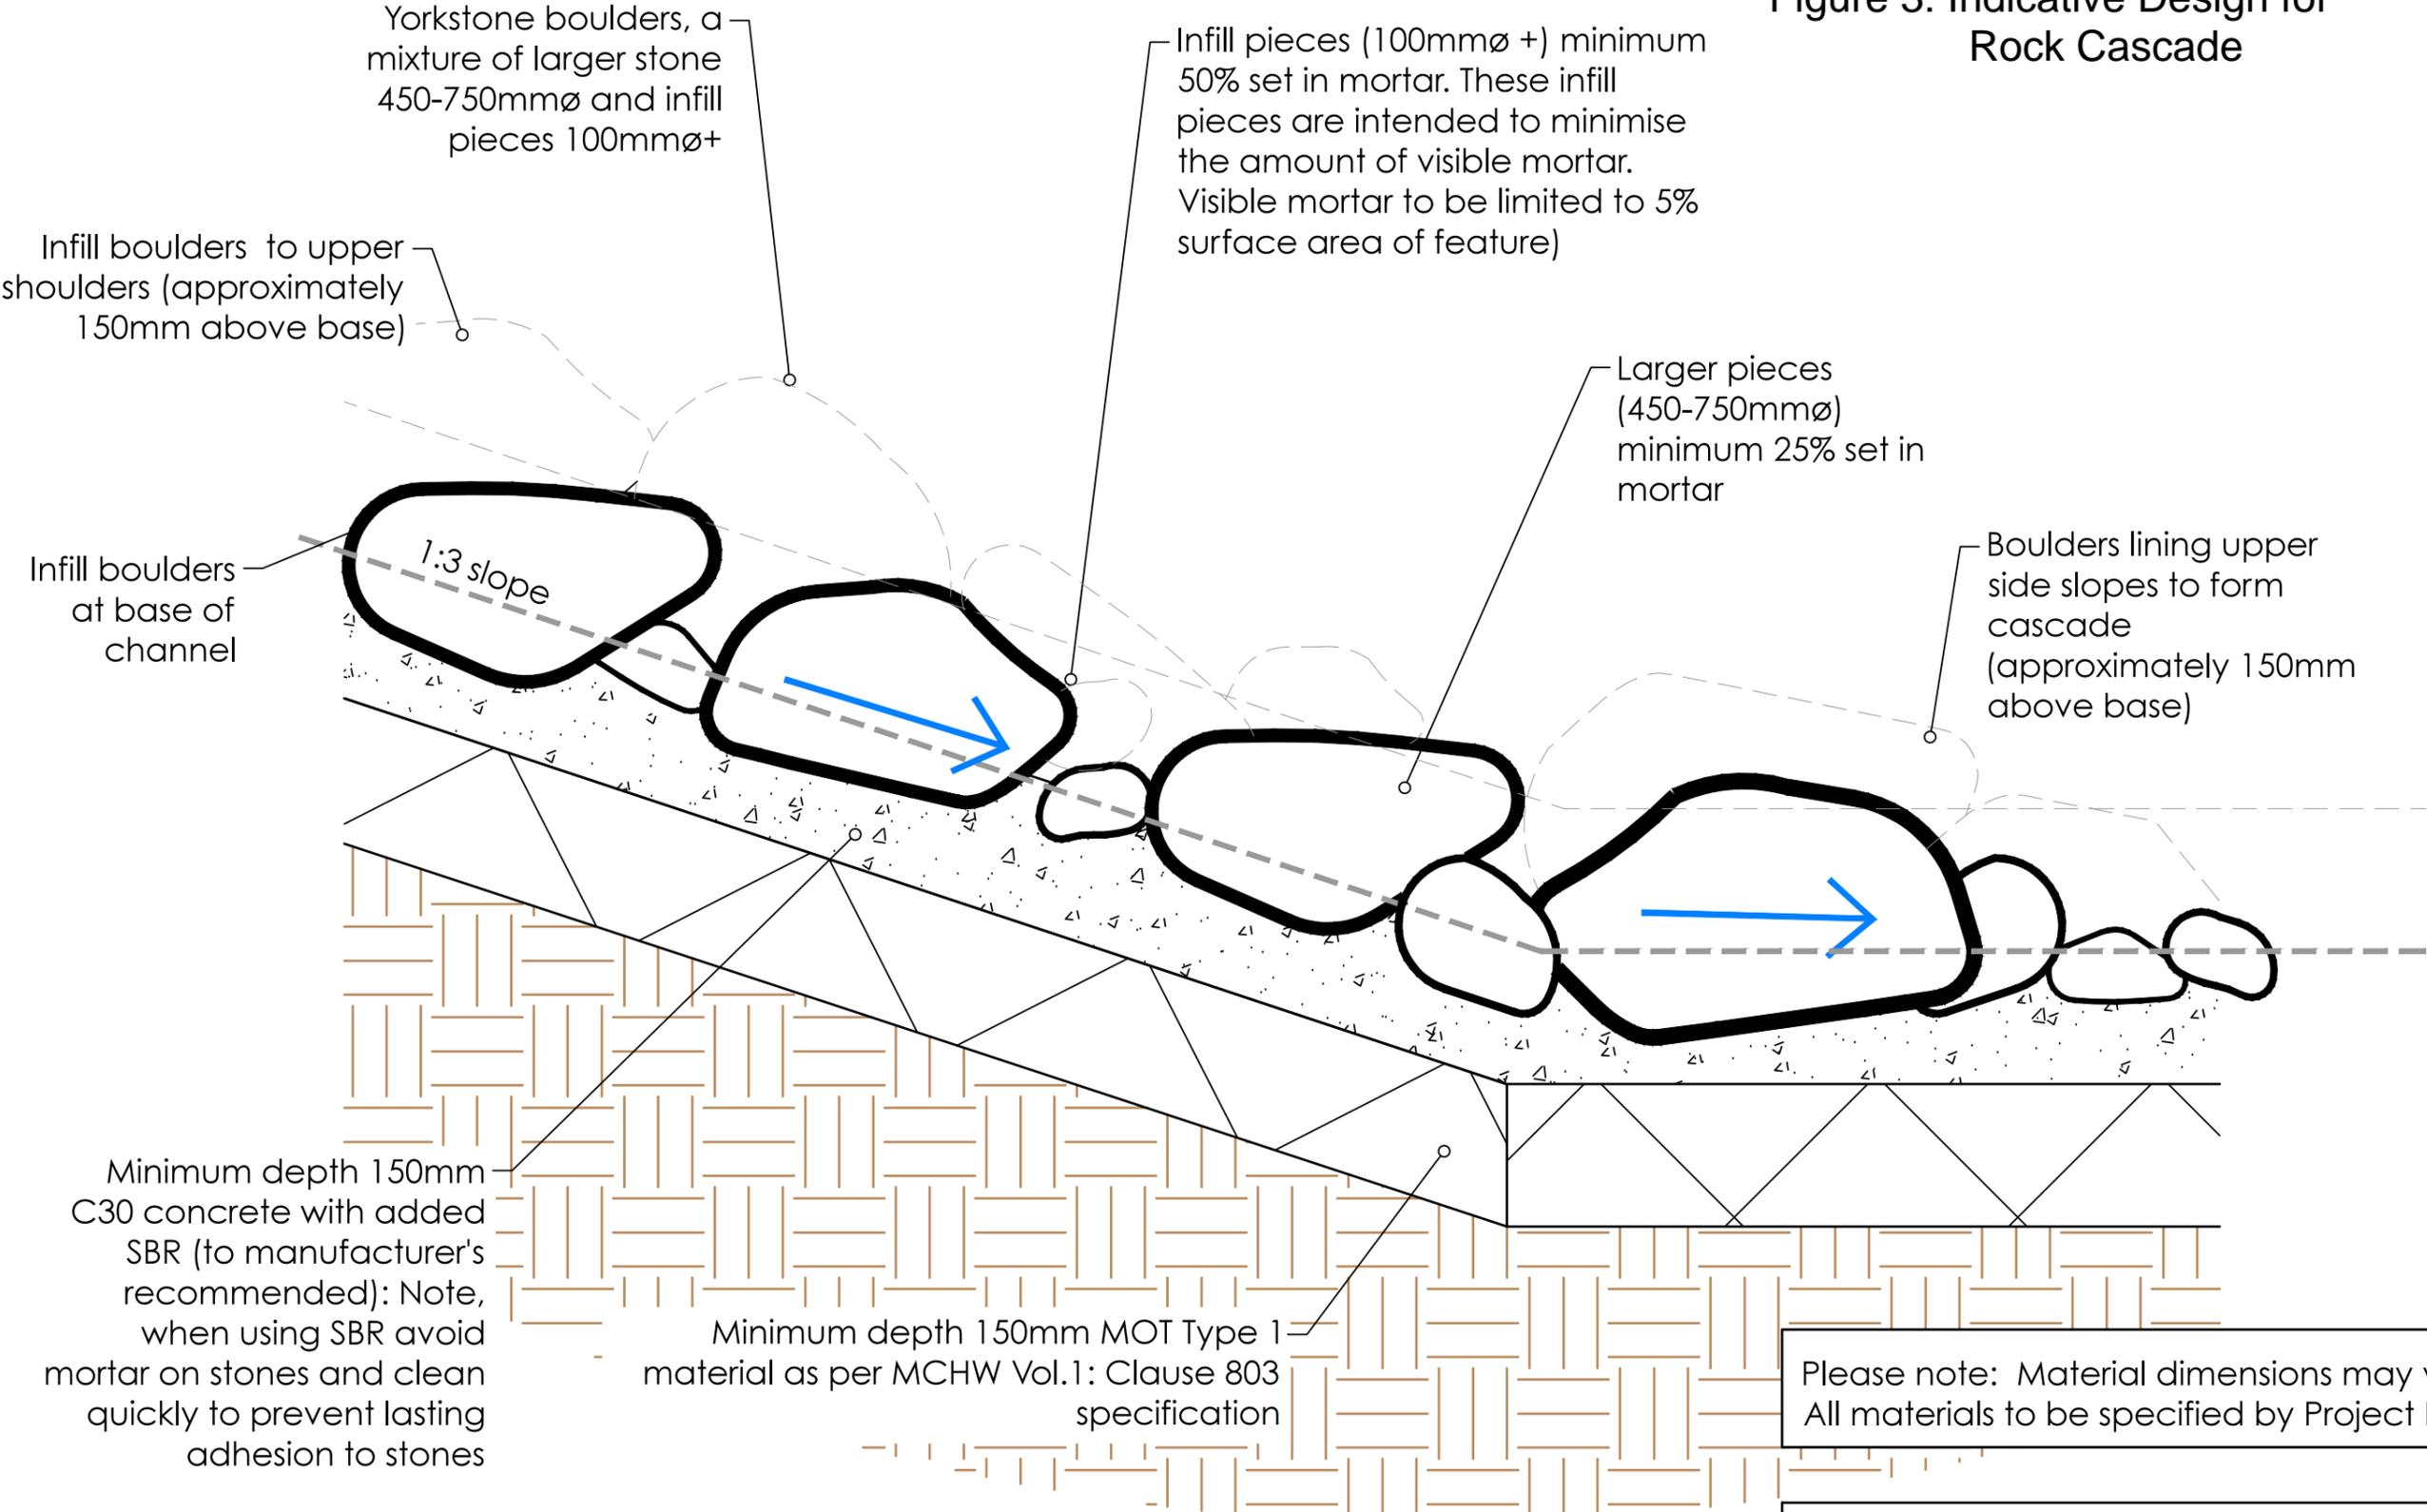
Figure 3: Indicative Design for Rock Cascade

Please note: Material dimensions may vary.
All materials to be specified by Project Engineer

- 5.2 It is assumed that the site currently drains to Clough Dike. The proposed surface water drainage scheme for the development will involve attenuation features, appropriate treatment trains such as oil traps and other features to ensure compliance with Sheffield City Council guidance for Sustainable Drainage Systems⁹. It is then proposed that the attenuated and treated water will be discharged at greenfield runoff rates to Clough Dike via an open overland channel with a rock cascade fill.

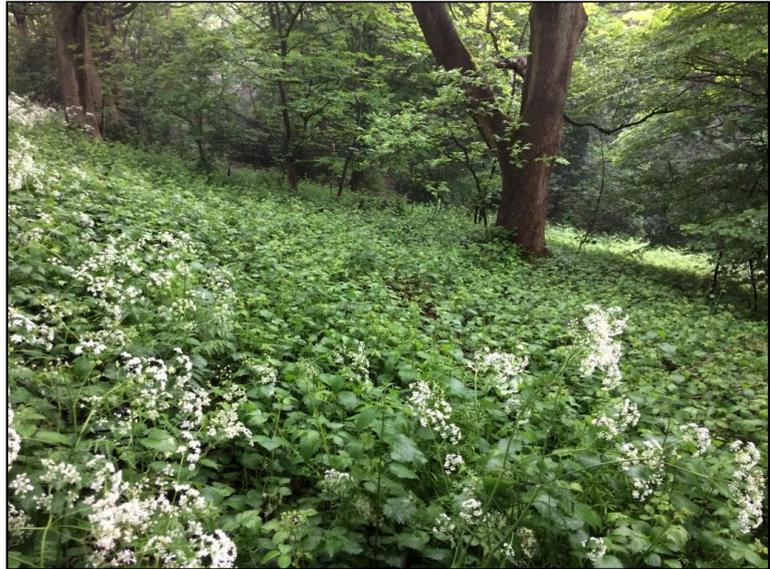
3.1 The southern boundary of the woodland in the survey area is formed by a drystone wall with a surfaced path a few feet inside the wood running parallel with the wall. From this path there is a steep north facing slope running down to Clough Dike in the valley bottom. An extensive area on the slope is dominated by bramble *Rubus fruticosus* agg. with

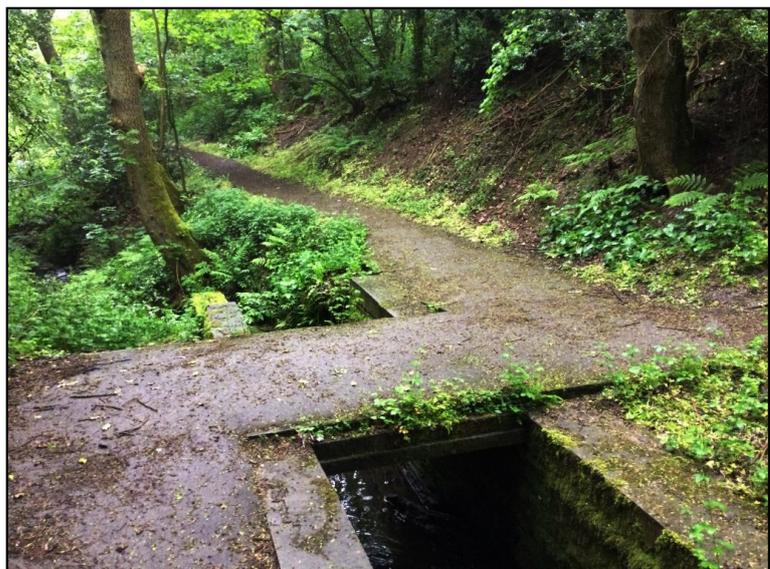
3.2 At the base of the slope the stream has been heavily modified; an artefact from when the valley was open land and a focal place for relaxation and public events for the local community ('The Glen' was gifted to the Deepcar and Stocksbridge communities in 1911)². Immediately downstream of this built structure the stream banks become relatively species rich (see Stream Margin species list in Table 1).
